SECTION 3.0 PRELIMINARY FACILITY CONDITION EVALUATION

3.0 Overview

3.1 Countywide Condition

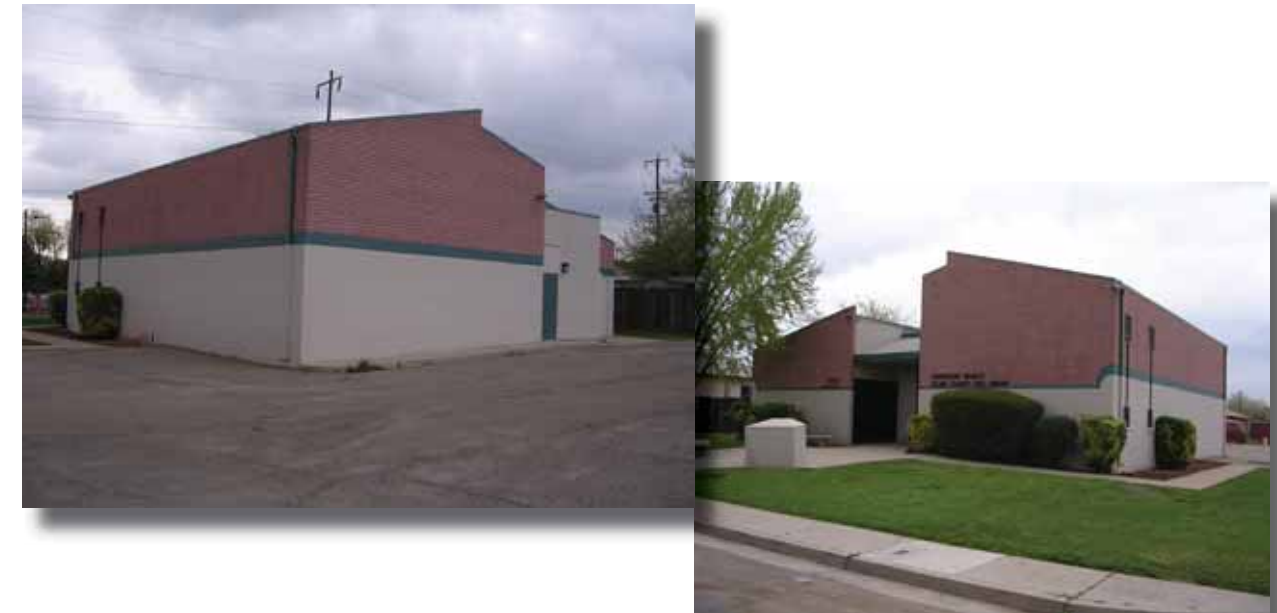
147 - Strathmore Library
19646 Road 230, Strathmore, Ca.

- General –** This facility is approximately 30 years old with a total size of 2762 gross square feet. The Building(s) is/are 1 story/stories tall and constructed of a/an Wood Framed and brick structure with a/an Slab on Grade floor diaphragm on a/an Conventional footings foundation. The exterior consists of Lath & Plaster, Lapped Wood Siding, and Brick Veneer in fair condition while the interior is Sound board, paint in fair condition. The roof on this facility consists of composition shingle roofing, in fair condition, on a wood framing structural roof system. The overall structural system is in fair condition. The suspended acoustical and exposed structural ceiling is rated to be in fair condition and the carpet and vinyl composition tiles (VCT) floor is rated in fair condition.

- Fire & Life Safety –** The fire alarm system on this building is a/an None with a/an None sprinkler system. The security system consists of None and is in (not rated or N/A) condition.

- HVAC –** The HVAC system in this building consists of a/an Package Units that was installed "unknown" and is rated to be in fair condition. The reported history of breakdowns on this system is: Has only happened once or twice

- Electrical –** The main electrical service (in amps) is 400 amps with the last upgrade being unknown. The electrical power system is rated to be in good condition and the electrical lighting is rated to be in fair condition. Telephone and data communication systems appear to be in fair condition.

- Abatement –** There may or may not be asbestos in this building. . There may or may not be lead based paint in this building.

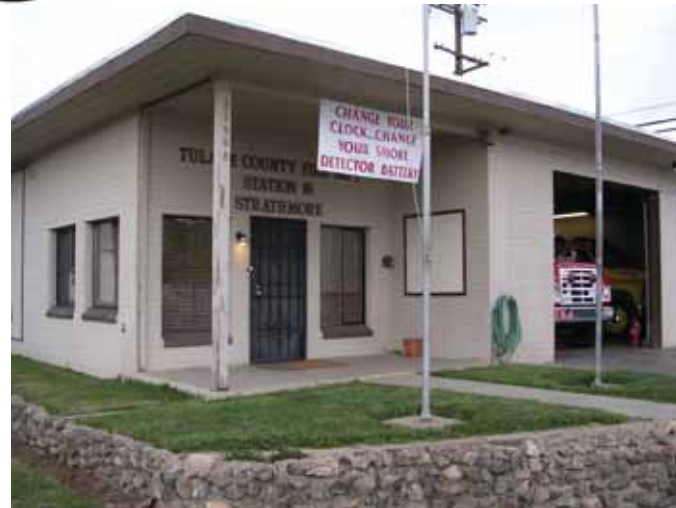
148 - Strathmore Fire Station
22908 Ave. 196, Strathmore, Ca.

General – This facility is approximately 56 years old with a total size of 2400 gross square feet. The Building(s) is/are 1 story/stories tall and constructed of a/an CMU structure with a/an Slab on Grade floor diaphragm on a/an Conventional footings foundation. The exterior consists of Exposed Concrete or CMU in fair condition while the interior is painted plaster in fair condition. The roof on this facility consists of built-up roofing, in good condition, on a wood framing structural roof system. The overall structural system is in fair condition. The suspended acoustical and gypsum wallboard or plaster ceiling is rated to be in poor condition and the carpet, vinyl composition tiles (VCT), and exposed concrete floor is rated in fair condition.

Fire & Life Safety – The fire alarm system on this building is a/an None with a/an None sprinkler system. The security system consists of None and is in (not rated or N/A) condition.

HVAC – The HVAC system in this building consists of a/an Package Units and Water Coolers that was installed "unknown" and is rated to be in fair condition. The reported history of breakdowns on this system is: Has only happened once or twice

Electrical – The main electrical service (in amps) is 150 amps with the last upgrade being unknown. The electrical power system is rated to be in fair condition and the electrical lighting is rated to be in fair condition. Telephone and data communication systems appear to be in fair condition.

Abatement – There may or may not be asbestos in this building. .
There may or may not be lead based paint in this building.

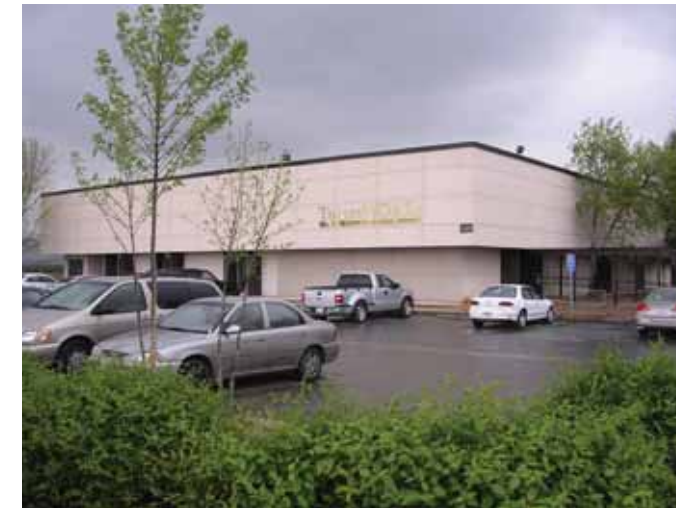
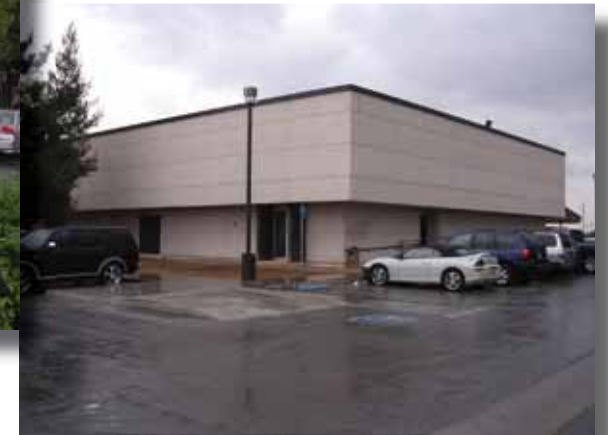
175 - Lindsay DPSS
900 No. Sequoia, Lindsay, Ca.

General – This facility is approximately 43 years old with a total size of 12704 gross square feet. The Building(s) is/are 1 story/stories tall and constructed of a/an Wood Framed structure with a/an Slab on Grade floor diaphragm on a/an Conventional footings foundation. The exterior consists of Lath & Plaster in good condition while the interior is sheetrock/paint in good condition. The roof on this facility consists of single-ply membrane roofing, in new condition, on a wood framing structural roof system. The overall structural system is in fair condition. The suspended acoustical ceiling is rated to be in fair condition and the carpet, vinyl composition tiles (VCT), and ceramic tile floor is rated in fair condition.

Fire & Life Safety – The fire alarm system on this building is a/an Fully automatic with heat and smoke detectors with a/an None sprinkler system. The security system consists of Door Alarms and Motion Sensors and is in fair condition.

HVAC – The HVAC system in this building consists of a/an Package Units that was installed 2003 and is rated to be in good condition. The reported history of breakdowns on this system is: Has only happened once or twice

Electrical – The main electrical service (in amps) is 600 amps with the last upgrade being unknown. The electrical power system is rated to be in good condition and the electrical lighting is rated to be in fair condition. Telephone and data communication systems appear to be in fair condition.

Abatement – There may or may not be asbestos in this building. .
There may or may not be lead based paint in this building.

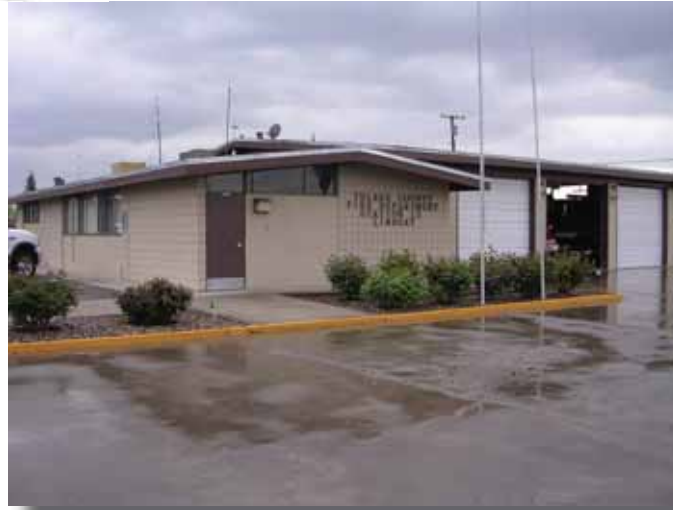
196 - Lindsay Fire Station
19603 Ave. 228, Lindsay, Ca.

- General –** This facility is approximately 42 years old with a total size of 4416 gross square feet. The Building(s) is/are 1 story/stories tall and constructed of a/an Wood Framed and CMU structure with a/an Slab on Grade floor diaphragm on a/an Conventional footings foundation. The exterior consists of Lath & Plaster, Exposed Concrete or CMU, and Plywood in fair condition while the interior is painted cmu, painted wall board in fair condition. The roof on this facility consists of built-up and composition shingle roofing, in fair condition, on a wood framing structural roof system. The overall structural system is in fair condition. The suspended acoustical, gypsum wallboard or plaster, and exposed structural ceiling is rated to be in fair condition and the carpet, vinyl asbestos tiles (VAT), and ceramic tile floor is rated in poor condition.

- Fire & Life Safety –** The fire alarm system on this building is a/an None with a/an None sprinkler system. The security system consists of None and is in (not rated or N/A) condition.

- HVAC –** The HVAC system in this building consists of a/an Split System that was installed 2003 and is rated to be in fair condition. The reported history of breakdowns on this system is: Has only happened once or twice

- Electrical –** The main electrical service (in amps) is 200 amps with the last upgrade being unknown. The electrical power system is rated to be in fair condition and the electrical lighting is rated to be in fair condition. Telephone and data communication systems appear to be in fair condition.

- Abatement –** There is asbestos in this building. Asbestos is located in: vat in several areas. There may or may not be lead based paint in this building.

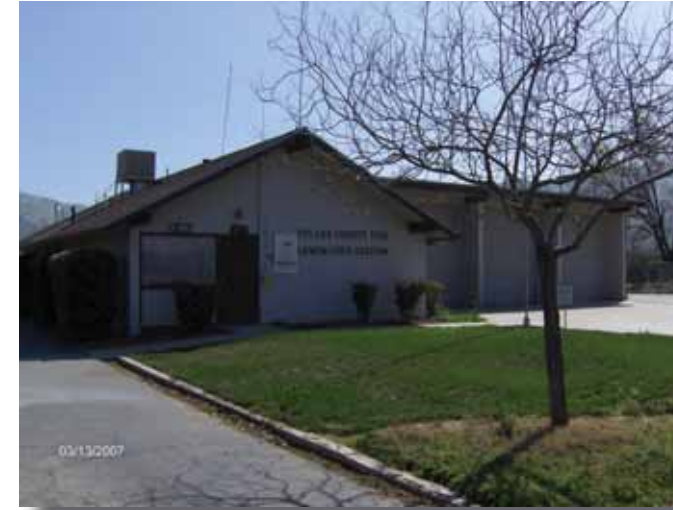
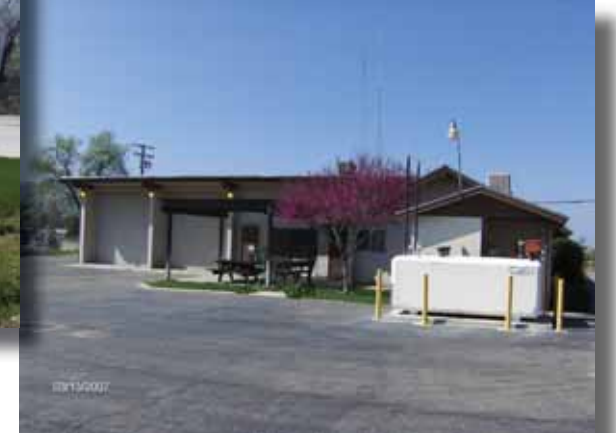
197 - Lemon Cove Fire Station
32490 Sierra Drive, Lemon Cove

- General –** This facility is approximately 31 years old with a total size of 4013 gross square feet. The Building(s) is/are 1 story/stories tall and constructed of a/an Wood Framed and CMU structure with a/an Slab on Grade floor diaphragm on a/an Conventional footings foundation. The exterior consists of Lath & Plaster and Exposed Concrete or CMU in good condition while the interior is sheetrock, painted in fair condition. The roof on this facility consists of built-up and composition shingle roofing, in fair condition, on a wood framing structural roof system. The overall structural system is in good condition. The unknown ceiling is rated to be in (not ranked or N/A) condition and the unknown floor is rated in (not ranked or N/A) condition.

- Fire & Life Safety –** The fire alarm system on this building is a/an None with a/an None sprinkler system. The security system consists of None and is in (not rated or N/A) condition.

- HVAC –** The HVAC system in this building consists of a/an Package Units and Water Coolers that was installed 2003 and is rated to be in fair condition. The reported history of breakdowns on this system is: Has only happened once or twice

- Electrical –** The main electrical service (in amps) is 200 amps with the last upgrade being unknown. The electrical power system is rated to be in fair condition and the electrical lighting is rated to be in fair condition. Telephone and data communication systems appear to be in fair condition.

- Abatement –** There may or may not be asbestos in this building. . There may or may not be lead based paint in this building.

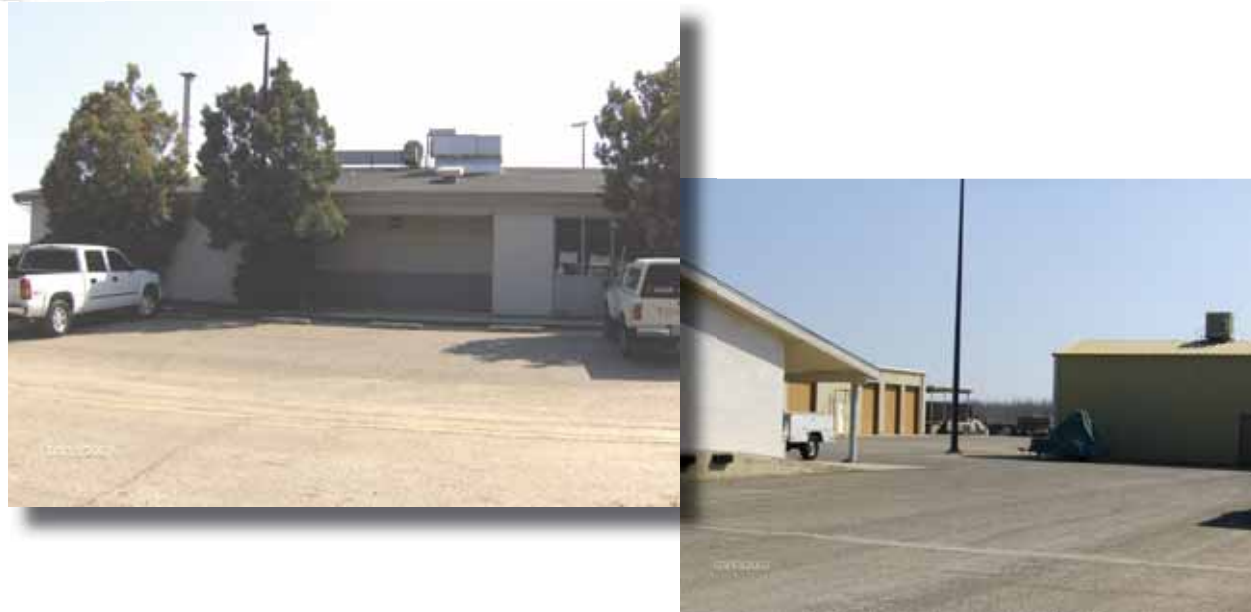
289 - Visalia Ag Warehouse
14173 Ave. 256, Visalia, Ca.

General – This facility is approximately 40 years old with a total size of 3886 gross square feet. The Building(s) is/are 1 story/stories tall and constructed of a/an Wood Framed, Steel structure with a/an Slab on Grade floor diaphragm on a/an Conventional footings foundation. The exterior consists of Lath & Plaster and Exposed Concrete or CMU in fair condition while the interior is painted and in fair condition. The roof on this facility consists of composition shingle roofing, in fair condition, on a wood framing structural roof system. The overall structural system is in fair condition. The ceiling is rated to be in fair condition and the carpet, vinyl asbestos tiles (VAT) and exposed concrete floor is rated in fair condition.

Fire & Life Safety – The fire alarm system on this building is a/an None with a/an None sprinkler system. The security system consists of None and is in (not rated or N/A) condition.

HVAC – The HVAC system in this building consists of a/an Package Units that was installed "unknown" and is rated to be in poor condition. The reported history of breakdowns on this system is: Regularly

Electrical – The main electrical service (in amps) is 400 amps with the last upgrade being unknown. The electrical power system is rated to be in fair condition and the electrical lighting is rated to be in fair condition. Telephone and data communication systems appear to be in fair condition.

Abatement – There is asbestos in this building. Asbestos is located in VAT in several areas. There may or may not be lead based paint in this building.

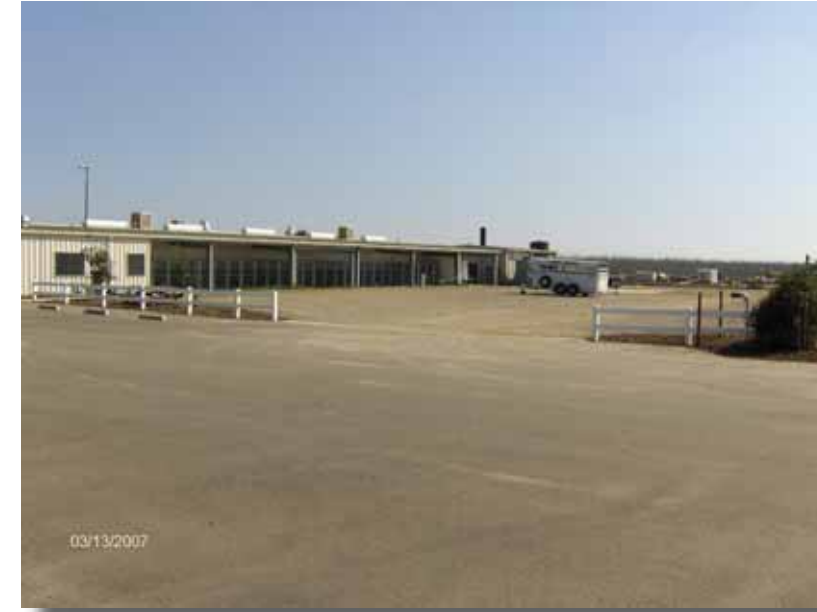
320 - Visalia Animal Control Facility
14131 Ave. 256, Visalia, Ca.

General – This facility is approximately 6 years old with a total size of 7466 gross square feet. The Building(s) is/are 1 story/stories tall and constructed of a/an Steel structure with a/an Slab on Grade floor diaphragm on a/an Conventional footings foundation. The exterior consists of Metal Panels in good condition while the interior is sheetrock, paint in good condition. The roof on this facility consists of metal roofing, in good condition, on a steel framing and metal roof panels structural roof system. The overall structural system is in good condition. The suspended acoustical, gypsum wallboard or plaster, and exposed structural ceiling is rated to be in good condition and the sheet vinyl and exposed concrete floor is rated in fair condition.

Fire & Life Safety – The fire alarm system on this building is a/an None with a/an None sprinkler system. The security system consists of None and is in (not rated or N/A) condition.

HVAC – The HVAC system in this building consists of a/an Package Units that was installed 2000 and is rated to be in good condition. The reported history of breakdowns on this system is: Never

Electrical – The main electrical service (in amps) is 200 amps with the last upgrade being 2000. The electrical power system is rated to be in good condition and the electrical lighting is rated to be in good condition. Telephone and data communication systems appear to be in good condition.

Abatement – There is not asbestos in this building. There is not lead based paint in this building.

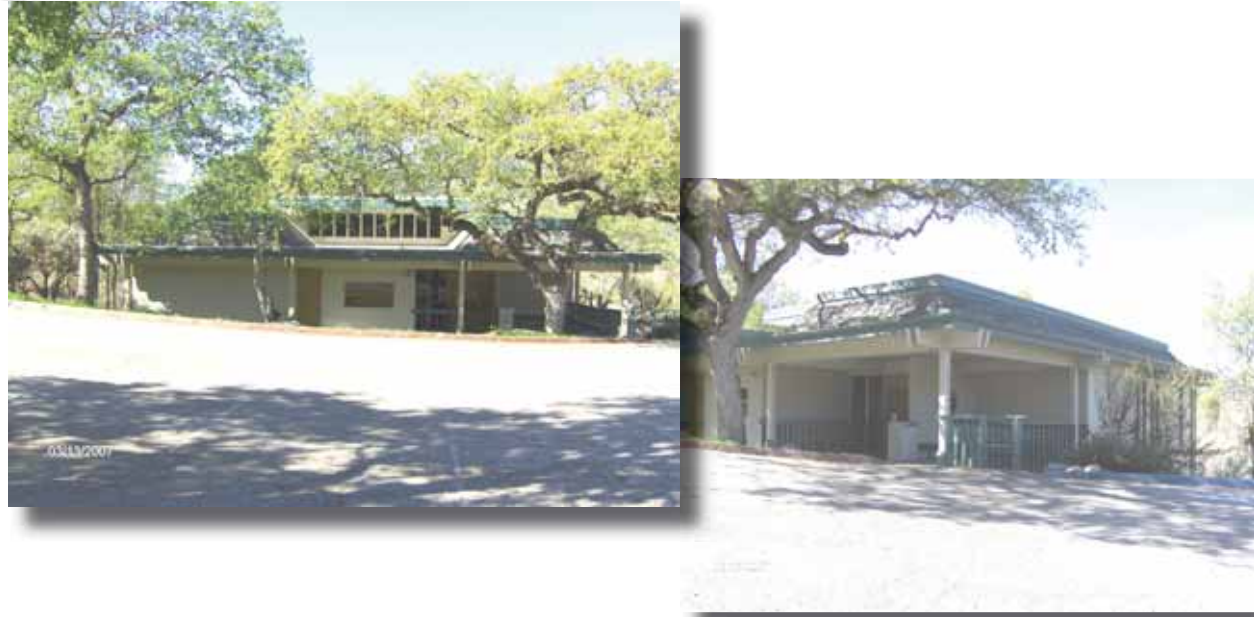
451 - Three Rivers Library
42052 Eggers Road, Three Rivers, Ca.

- General –** This facility is approximately 31 years old with a total size of 2655 gross square feet. The Building(s) is/are 1 story/stories tall and constructed of a/an Wood Framed structure with a/an Wood framed floor diaphragm on a/an Posts and Piers foundation. The exterior consists of Lapped Wood Siding in fair condition while the interior is wood/painted in good condition. The roof on this facility consists of built-up roofing, in fair condition, on a wood framing structural roof system. The overall structural system is in fair condition. The 12x12 tile ceiling is rated to be in fair condition and the carpet and vinyl composition tiles (VCT) floor is rated in fair condition.

- Fire & Life Safety –** The fire alarm system on this building is a/an None with a/an None sprinkler system. The security system consists of None and is in (not rated or N/A) condition.

- Abatement –** There may or may not be asbestos in this building. There may or may not be lead based paint in this building.
