SECTION 3.0 PRELIMINARY FACILITY CONDITION EVALUATION

3.0 Overview

3.1 Countywide Condition

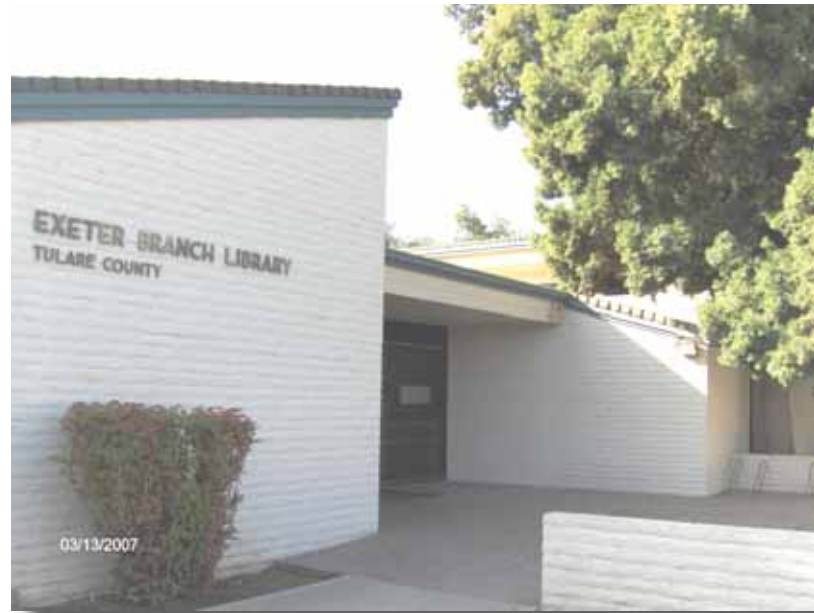
124 - Exeter Library
230 E. Chestnut, Exeter, Ca.

- General –** This facility is approximately 35 years old with a total size of 4800 gross square feet. The Building(s) is/are 1 story/stories tall and constructed of a/an CMU structure with a/an Slab on Grade floor diaphragm on a/an Conventional footings foundation. The exterior consists of Exposed Concrete or CMU in good condition while the interior is Sound Board, CMU, Wood Panels in fair condition. The roof on this facility consists of built-up and composition shingle roofing, in fair condition, on a wood framing structural roof system. The overall structural system is in good condition. The 12x12 tile and wood ceiling is rated to be in fair condition and the carpet and vinyl composition tiles (VCT) floor is rated in fair condition.

- Fire & Life Safety –** The fire alarm system on this building is a/an None with a/an None sprinkler system. The security system consists of None and is in (not rated or N/A) condition.

- HVAC –** The HVAC system in this building consists of a/an Package Units that was installed 2003 and is rated to be in good condition. The reported history of breakdowns on this system is: Has only happened once or twice

- Electrical –** The main electrical service (in amps) is 600 amps with the last upgrade being unknown. The electrical power system is rated to be in good condition and the electrical lighting is rated to be in fair condition. Telephone and data communication systems appear to be in fair condition.

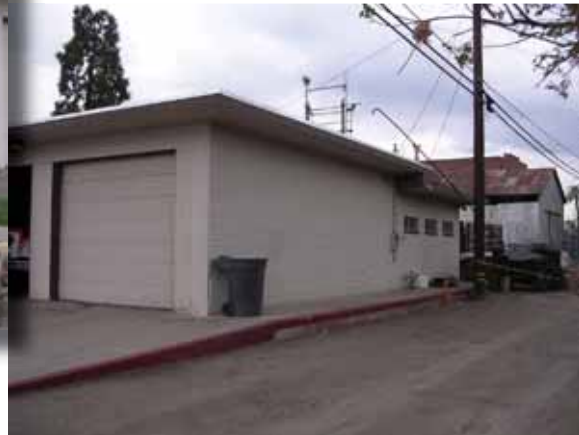
148 - Strathmore Fire Station
22908 Ave. 196, Strathmore, Ca.

General – This facility is approximately 56 years old with a total size of 2400 gross square feet. The Building(s) is/are 1 story/stories tall and constructed of a/an CMU structure with a/an Slab on Grade floor diaphragm on a/an Conventional footings foundation. The exterior consists of Exposed Concrete or CMU in fair condition while the interior is painted plaster in fair condition. The roof on this facility consists of built-up roofing, in good condition, on a wood framing structural roof system. The overall structural system is in fair condition. The suspended acoustical and gypsum wallboard or plaster ceiling is rated to be in poor condition and the carpet, vinyl composition tiles (VCT), and exposed concrete floor is rated in fair condition.

Fire & Life Safety – The fire alarm system on this building is a/an None with a/an None sprinkler system. The security system consists of None and is in (not rated or N/A) condition.

HVAC – The HVAC system in this building consists of a/an Package Units and Water Coolers that was installed "unknown" and is rated to be in fair condition. The reported history of breakdowns on this system is: Has only happened once or twice

Electrical – The main electrical service (in amps) is 150 amps with the last upgrade being unknown. The electrical power system is rated to be in fair condition and the electrical lighting is rated to be in fair condition. Telephone and data communication systems appear to be in fair condition.

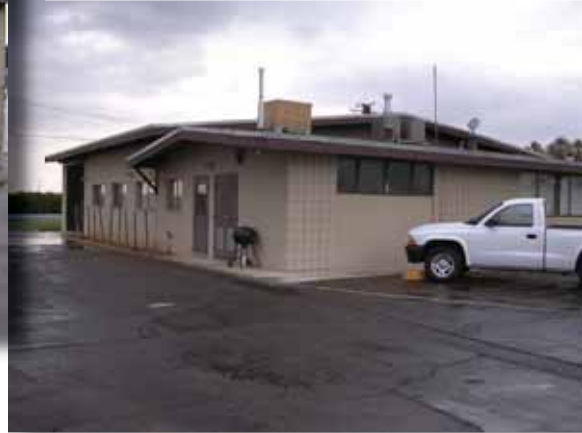
196 - Lindsay Fire Station
19603 Ave. 228, Lindsay, Ca.

- General –** This facility is approximately 42 years old with a total size of 4416 gross square feet. The Building(s) is/are 1 story/stories tall and constructed of a/an Wood Framed and CMU structure with a/an Slab on Grade floor diaphragm on a/an Conventional footings foundation. The exterior consists of Lath & Plaster, Exposed Concrete or CMU, and Plywood in fair condition while the interior is painted cmu, painted wall board in fair condition. The roof on this facility consists of built-up and composition shingle roofing, in fair condition, on a wood framing structural roof system. The overall structural system is in fair condition. The suspended acoustical, gypsum wallboard or plaster, and exposed structural ceiling is rated to be in fair condition and the carpet, vinyl asbestos tiles (VAT), and ceramic tile floor is rated in poor condition.

- Fire & Life Safety –** The fire alarm system on this building is a/an None with a/an None sprinkler system. The security system consists of None and is in (not rated or N/A) condition.

- HVAC –** The HVAC system in this building consists of a/an Split System that was installed 2003 and is rated to be in fair condition. The reported history of breakdowns on this system is: Has only happened once or twice

- Electrical –** The main electrical service (in amps) is 200 amps with the last upgrade being unknown. The electrical power system is rated to be in fair condition and the electrical lighting is rated to be in fair condition. Telephone and data communication systems appear to be in fair condition.

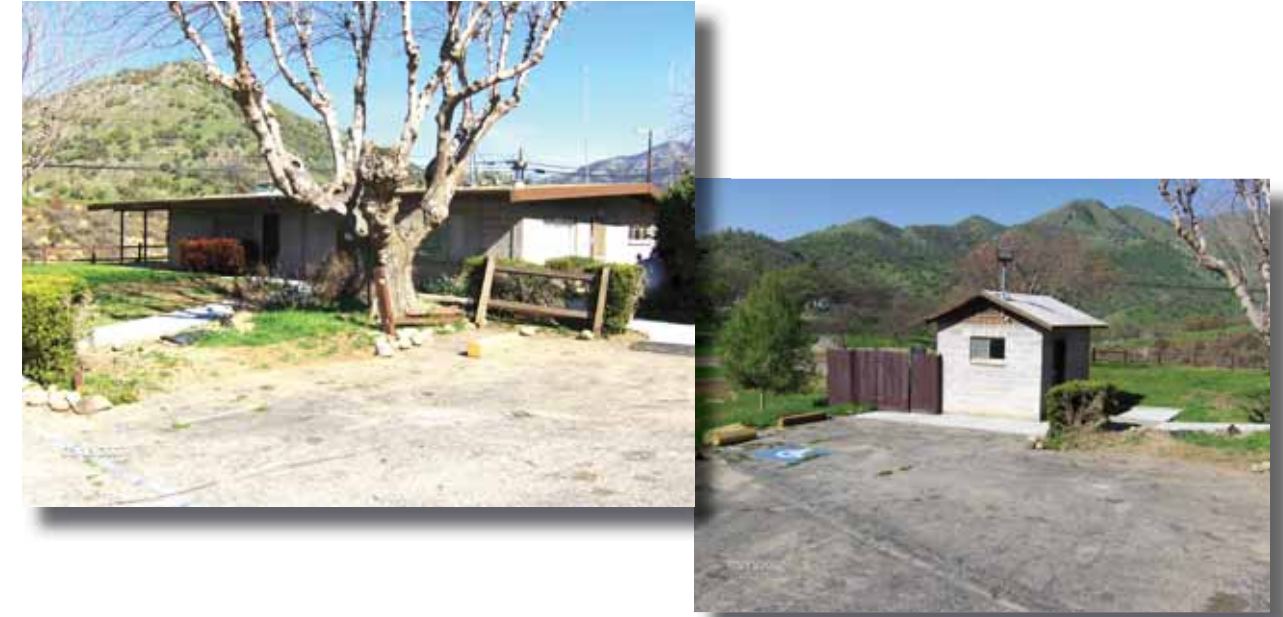
492 - Three Rivers Fire Station
41412 South Fork Drive, Three Rivers, Ca.

- General –** This facility is approximately 50 years old with a total size of 2122 gross square feet. The Building(s) is/are 1 story/stories tall and constructed of a/an Wood Framed and CMU structure with a/an Slab on Grade floor diaphragm on a/an Conventional footings foundation. The exterior consists of Exposed Concrete or CMU in good condition while the interior is sheetrock/paint in fair condition. The roof on this facility consists of built-up, in poor condition, on a wood framing structural roof system. The overall structural system is in fair condition. The gypsum wallboard or plaster and exposed structural ceiling is rated to be in fair condition and the carpet and sheet vinyl floor is rated in poor condition.

- This facility is scheduled for an extensive remodel in 2007.
- Fire & Life Safety –** The fire alarm system on this building is a/an None with a/an None sprinkler system. The security system consists of None and is in (not rated or N/A) condition.

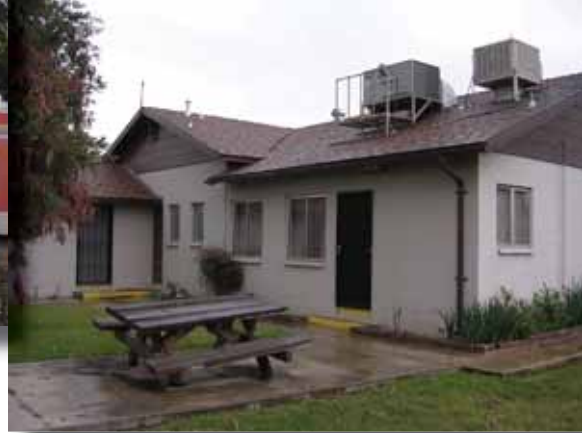
189 - Woodville Fire Station
16756 Ave. 168, Woodville, Ca.

Electrical – The main electrical service (in amps) is 200 amps with the last upgrade being unknown. The electrical power system is rated to be in fair condition and the electrical lighting is rated to be in fair condition. Telephone and data communication systems appear to be in fair condition.

Abatement – There may or may not be asbestos in this building. .
There may or may not be lead based paint in this building.

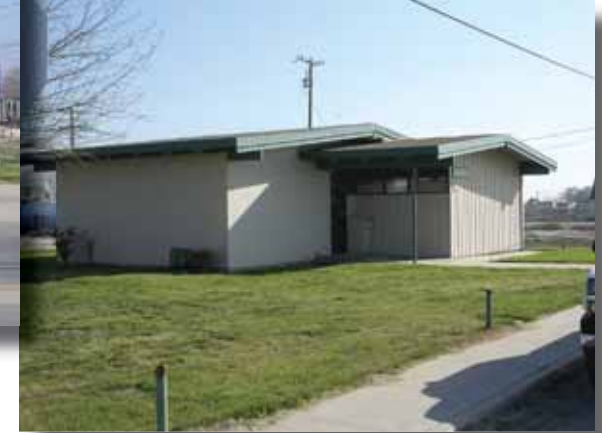
211 - Alpaugh Library
3816 Ave. 228, Alpaugh, Ca.

Electrical – The main electrical service (in amps) is 100 amps with the last upgrade being unknown. The electrical power system is rated to be in fair condition and the electrical lighting is rated to be in fair condition. Telephone and data communication systems appear to be in fair condition.

Abatement – There may or may not be asbestos in this building. .
There may or may not be lead based paint in this building.

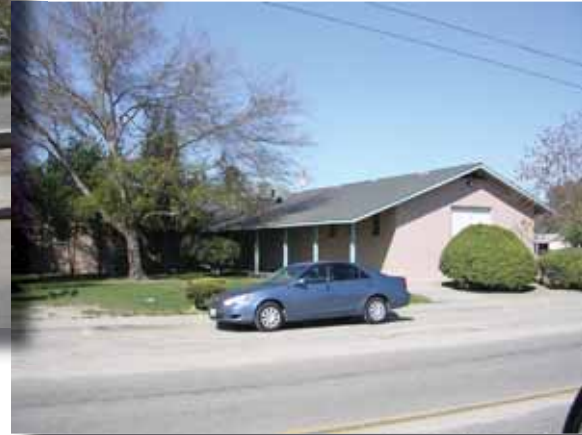
236 - Pixley Sheriff Substation
151 No. Pine, Pixley, Ca.

Electrical – The main electrical service (in amps) is 400 amps with the last upgrade being unknown. The electrical power system is rated to be in fair condition and the electrical lighting is rated to be in fair condition. Telephone and data communication systems appear to be in poor condition.

Abatement – There is asbestos in this building. Asbestos is located in: vat and plaster. There is lead based paint in this building.

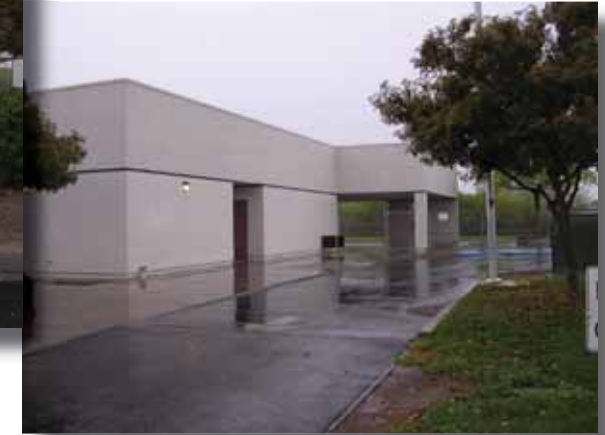
246 - Tulare Community School
1105 So. "O" Street, Tulare, Ca.

Electrical – The main electrical service (in amps) is 400 amps with the last upgrade being unknown. The electrical power system is rated to be in fair condition and the electrical lighting is rated to be in fair condition. Telephone and data communication systems appear to be in fair condition.

Abatement – There may or may not be asbestos in this building. . There may or may not be lead based paint in this building.

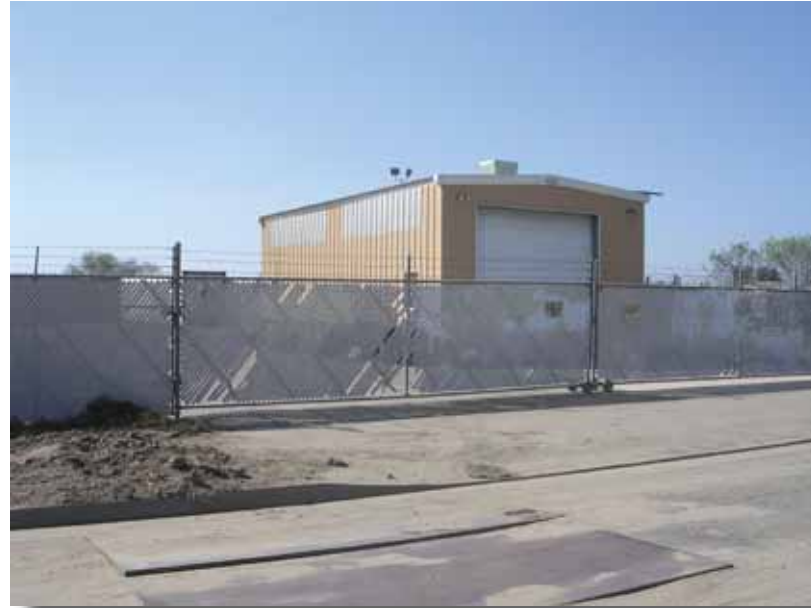
247 - Tulare HHS Storage
1275 So. "O" St., Tulare, Ca.

Electrical – The main electrical service (in amps) is unknown with the last upgrade being unknown. The electrical power system is rated to be in (not rated or N/A) condition and the electrical lighting is rated to be in fair condition. Telephone and data communication systems appear to be in N/A (None Exist) condition.

Abatement – There may or may not be asbestos in this building. . There may or may not be lead based paint in this building.

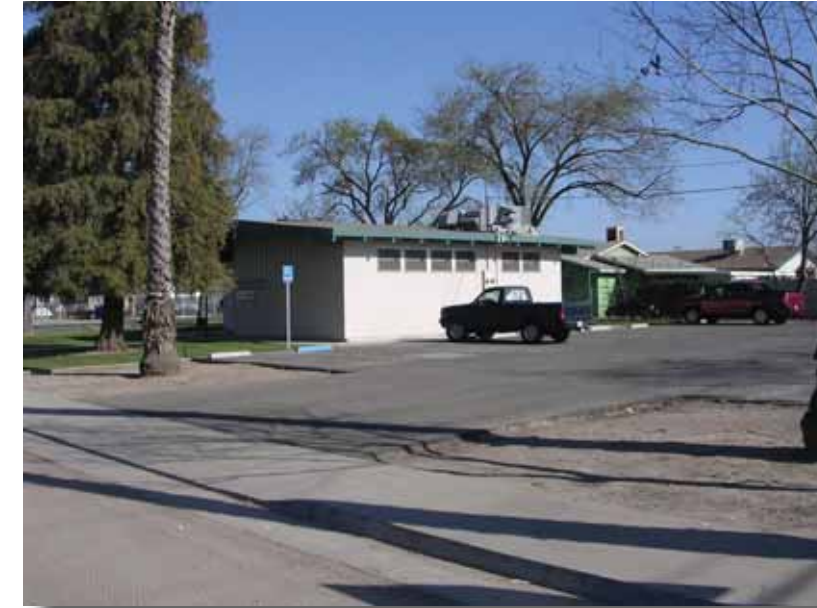
251 - Tipton Library
301 E. Woods, Tipton, Ca.

Electrical – The main electrical service (in amps) is 100 amps with the last upgrade being unknown. The electrical power system is rated to be in fair condition and the electrical lighting is rated to be in fair condition. Telephone and data communication systems appear to be in fair condition.

Abatement – There is asbestos in this building. Asbestos is located in: vat. There may or may not be lead based paint in this building.

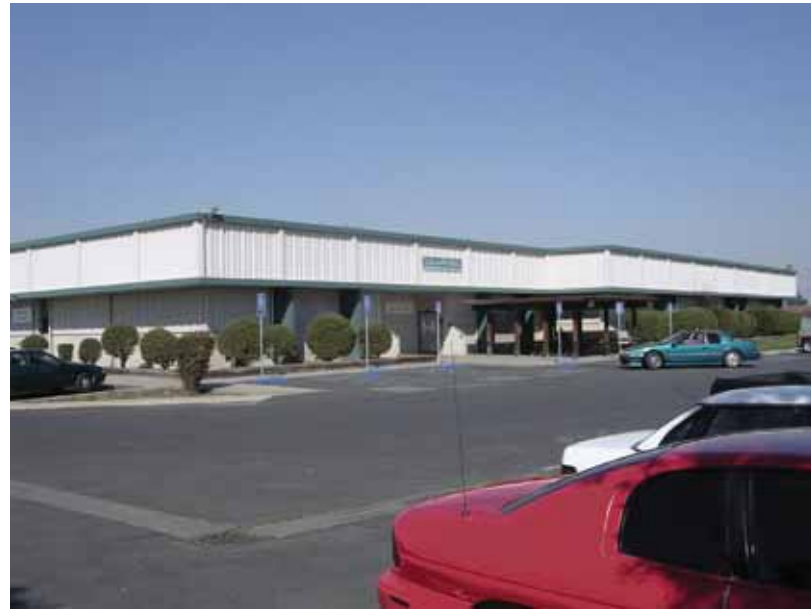
253 - Tulare DPSS
458 E. O'neal, Tulare, Ca.

- Electrical –** The main electrical service (in amps) is 600 amps with the last upgrade being unknown. The electrical power system is rated to be in fair condition and the electrical lighting is rated to be in fair condition. Telephone and data communication systems appear to be in fair condition.

- Abatement –** There may or may not be asbestos in this building. There may or may not be lead based paint in this building.

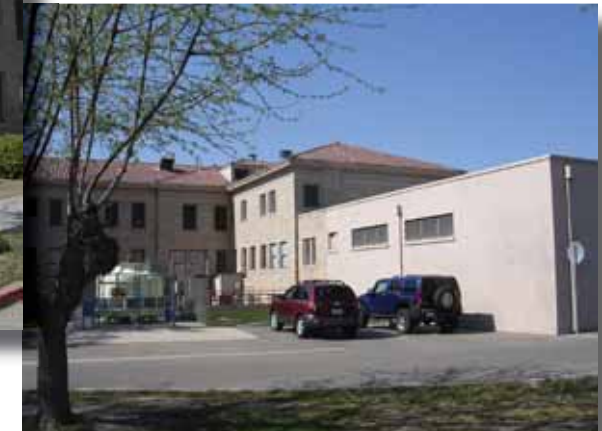
254 - Tulare Hillman Health Center
1062 So. "K" St., Tulare, Ca.

- Electrical –** The main electrical service (in amps) is 1200 amps with the last upgrade being 1992. The electrical power system is rated to be in fair condition and the electrical lighting is rated to be in fair condition. Telephone and data communication systems appear to be in fair condition.

- Abatement –** There is asbestos in this building. Asbestos is located in: tsi on pipes, plaster walls-ceilings. There is lead based paint in this building.

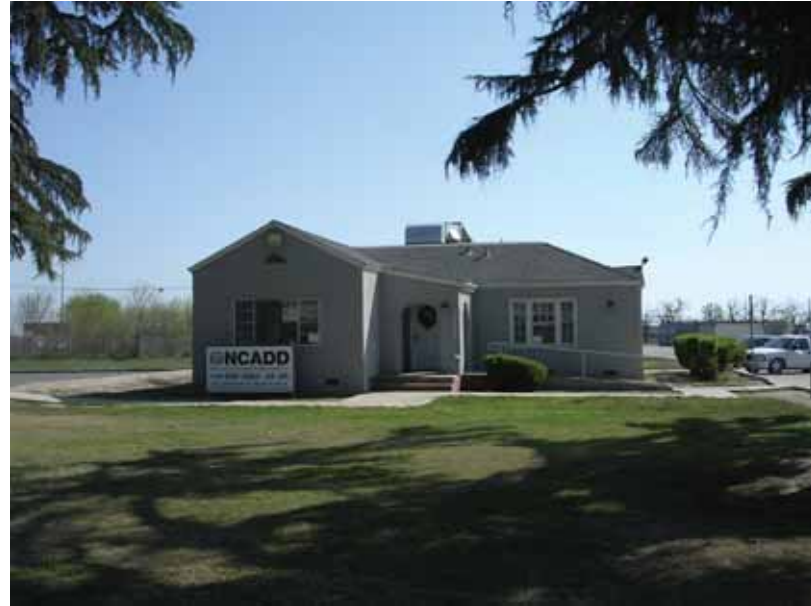
255 - Tulare Alcohol Detox
525 E. Bardsley, Tulare, Ca.

- Electrical –** The main electrical service (in amps) is not provided with the last upgrade being unknown. The electrical power system is rated to be in fair condition and the electrical lighting is rated to be in fair condition. Telephone and data communication systems appear to be in fair condition.

- Abatement –** There may or may not be asbestos in this building. .
There may or may not be lead based paint in this building.

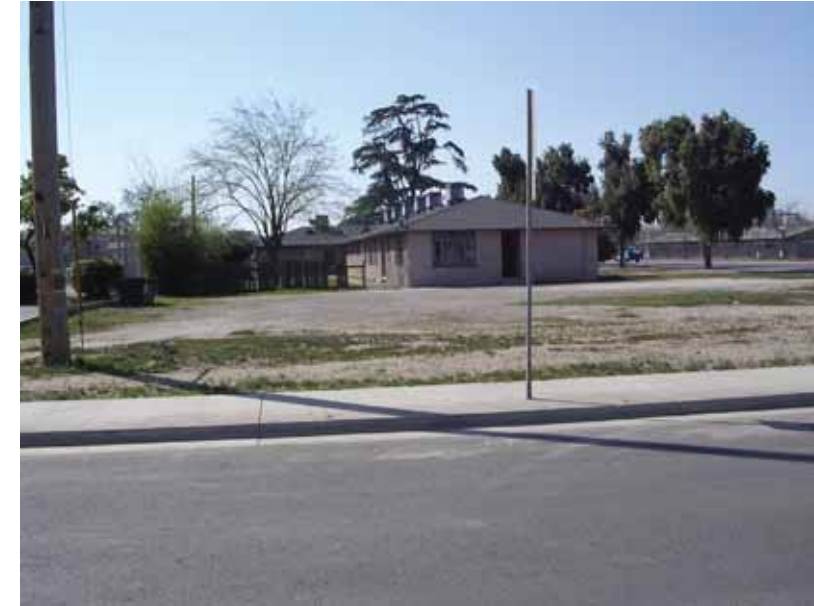
256 - Tulare Drug Abuse
559 E. Bardsley, Tulare, Ca.

- Electrical –** The main electrical service (in amps) is 400 amps with the last upgrade being 2003. The electrical power system is rated to be in fair condition and the electrical lighting is rated to be in fair condition. Telephone and data communication systems appear to be in fair condition.

- Abatement –** There may or may not be asbestos in this building. .
There may or may not be lead based paint in this building.

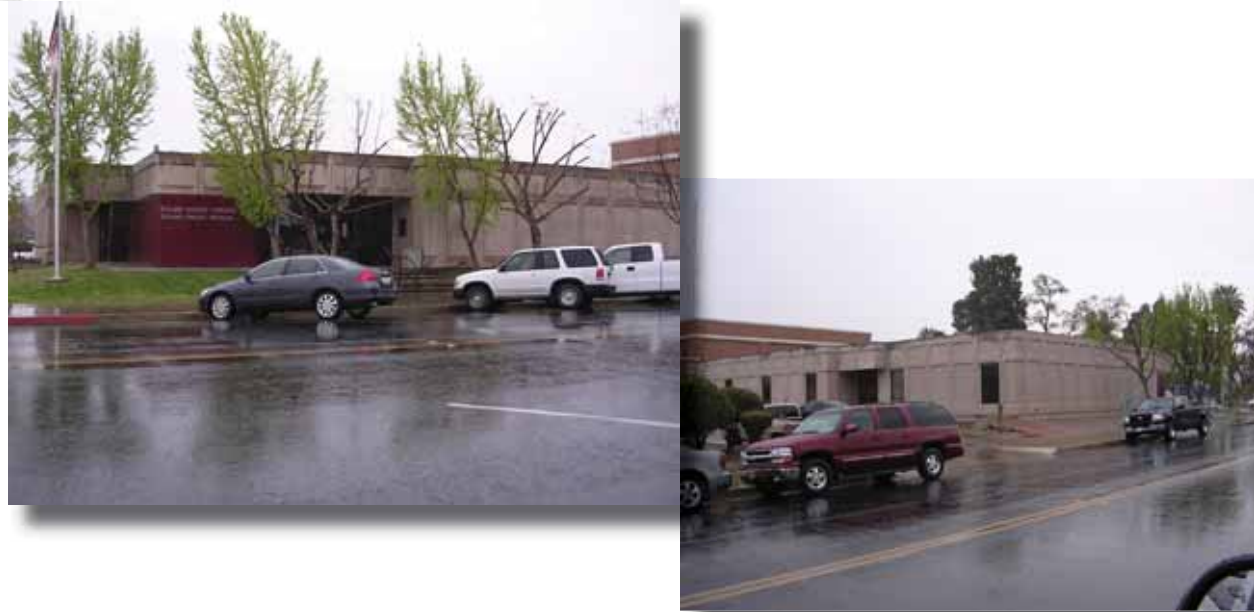
257 - Tulare Superior Court
425 E. Kern, Tulare, Ca.

- Electrical –** The main electrical service (in amps) is 1200 amps with the last upgrade being unknown. The electrical power system is rated to be in fair condition and the electrical lighting is rated to be in fair condition. Telephone and data communication systems appear to be in fair condition.

- Abatement –** There may or may not be asbestos in this building. .
There may or may not be lead based paint in this building.

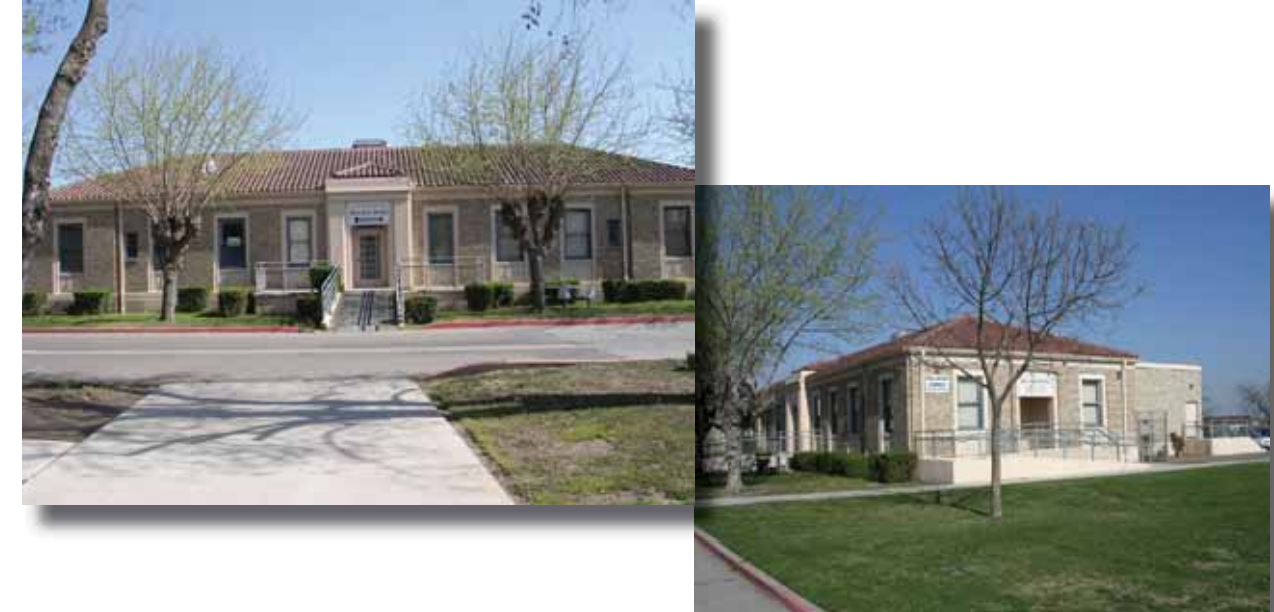
258 - Tulare Hillman Annex (H&HS)
1150 So. "K" St., Tulare, Ca.

- Electrical –** The main electrical service (in amps) is power comes from 254 with the last upgrade being 1992. The electrical power system is rated to be in fair condition and the electrical lighting is rated to be in fair condition. Telephone and data communication systems appear to be in fair condition.

- Abatement –** There may or may not be asbestos in this building. .
There may or may not be lead based paint in this building.

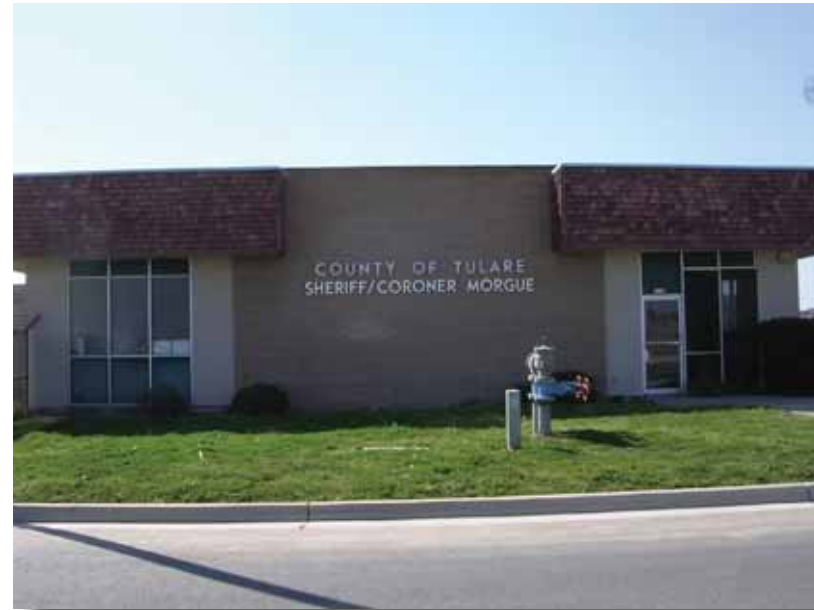
259 - Tulare Morgue
1225 So. "O" St., Tulare, Ca.

Electrical – The main electrical service (in amps) is 400 amps with the last upgrade being 1982. The electrical power system is rated to be in fair condition and the electrical lighting is rated to be in fair condition. Telephone and data communication systems appear to be in fair condition.

Abatement – There may or may not be asbestos in this building. .
There may or may not be lead based paint in this building.

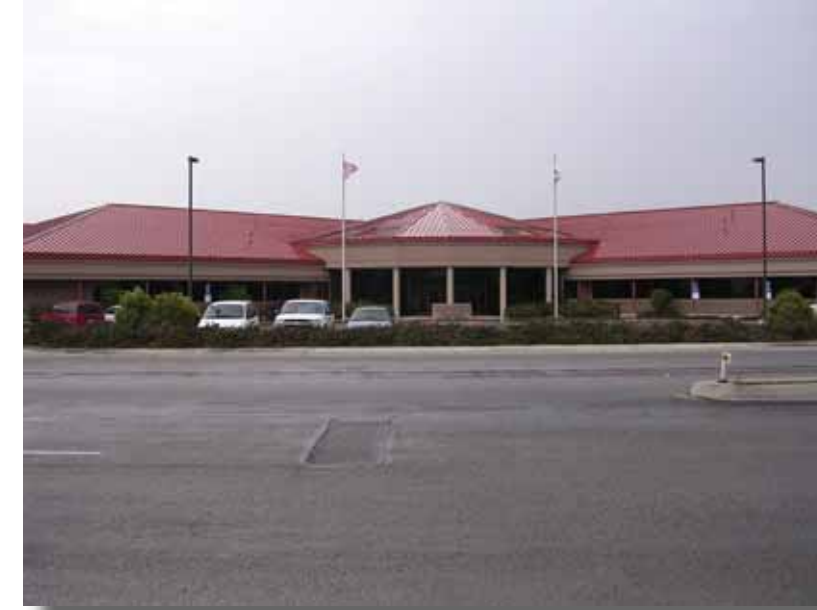
266 - Tulare Ag Building
4437 So. Laspina, Tulare, Ca

Electrical – The main electrical service (in amps) is 1200 amps with the last upgrade being 2000. The electrical power system is rated to be in good condition and the electrical lighting is rated to be in good condition. Telephone and data communication systems appear to be in good condition.

Abatement – There is not asbestos in this building. .
There is not lead based paint in this building.

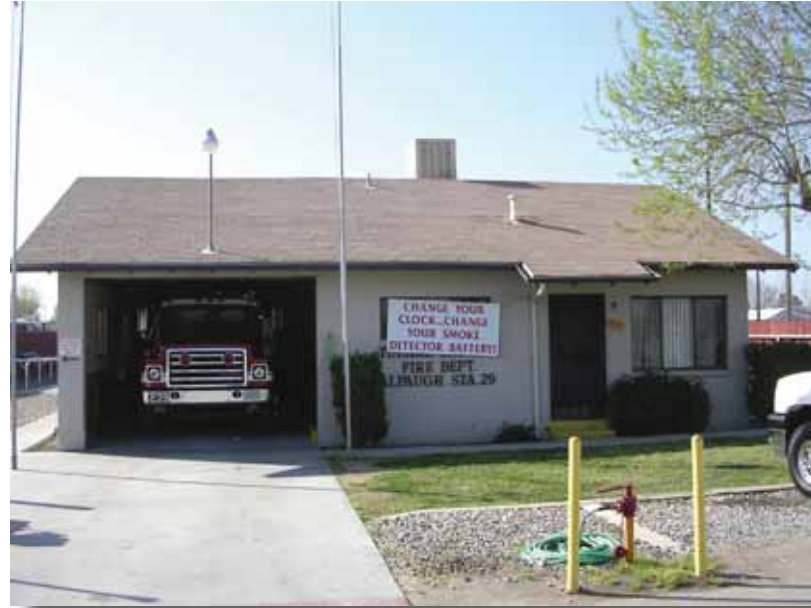
299 - Alpaugh Fire Station
3939 Ave. 54, Alpaugh, Ca.

General – This facility is approximately 46 years old with a total size of 1388 gross square feet. The Building(s) is/are 1 story/stories tall and constructed of a/an Wood Framed and CMU structure with a/an Slab on Grade floor diaphragm on a/an Conventional footings foundation. The exterior consists of Exposed Concrete or CMU in poor condition while the interior is plaster/paint in poor condition. The roof on this facility consists of composition shingle roofing, in fair condition, on a wood framing structural roof system. The overall structural system is in poor condition. The gypsum wallboard or plaster ceiling is rated to be in fair condition and the carpet and sheet vinyl floor is rated in poor condition.

HVAC – The HVAC system in this building consists of a/an Gas Furnace and Water Cooler that was installed "unknown" and is rated to be in poor condition. The reported history of breakdowns on this system is: Regularly

Electrical – The main electrical service (in amps) is 100 amps with the last upgrade being unknown. The electrical power system is rated to be in poor condition and the electrical lighting is rated to be in fair condition. Telephone and data communication systems appear to be in poor condition.

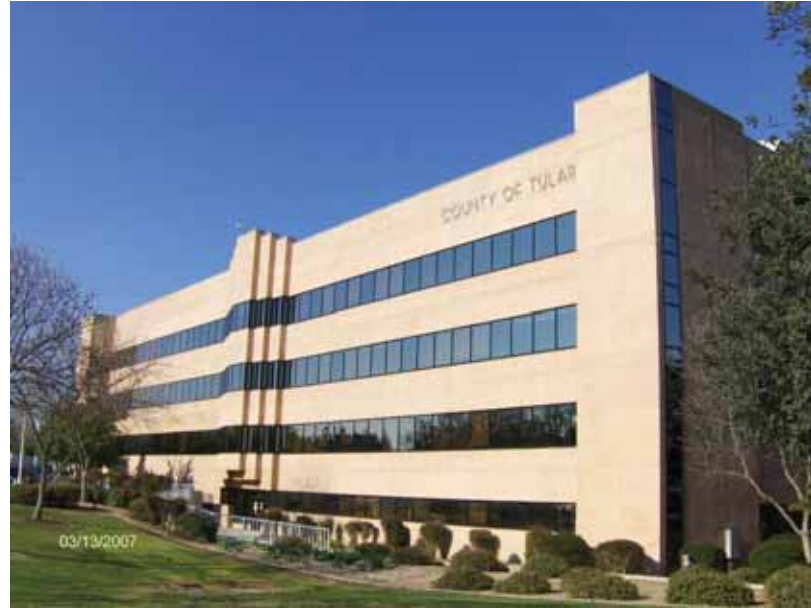
301 - Visalia Superior Court House
221 So. Mooney Blvd., Visalia, Ca.

- General –** This facility is approximately 49 years old with a total size of 231455 gross square feet. The Building(s) is/are 4 story/stories tall and constructed of a/an Concrete and Steel structure with a/an Slab on Grade floor diaphragm on a/an Conventional footings foundation. The exterior consists of Lath & Plaster, Exposed Concrete or CMU, Metal Panels, Brick Veneer, and Concrete Veneer in fair condition while the interior is plaster/drywall - painted in fair condition. The roof on this facility consists of built-up roofing, in fair condition, on a steel framing with topping slab structural roof system. The overall structural system is in fair condition. The suspended acoustical, gypsum wallboard or plaster, 12x12 tile, and exposed structural ceiling is rated to be in fair condition and the carpet, vinyl composition tiles (VCT), vinyl asbestos tiles (VAT), ceramic tile, sheet vinyl, terrazzo, and exposed concrete floor is rated in fair condition.

- Fire & Life Safety –** The fire alarm system on this building is a/an Fully automatic with heat and smoke detectors with a/an Wet System, throughout building sprinkler system. The security system consists of Door Alarms, Security Cameras, and interior/exterior card readers at doors and is in fair condition.

- HVAC –** The HVAC system in this building consists of a/an Package Units, 2 Split Systems, 1 Liebert, and Central Plant with Boiler, Chiller, and Fan Coil Units that was installed 1958 thru 2004 and is rated to be in good condition. The reported history of breakdowns on this system is: Has only happened once or twice

- Electrical –** The main electrical service (in amps) is 1200 amps in old wing and 1200 amp in new wing with the last upgrade being 1988. The electrical power system is rated to be in good condition and the electrical lighting is rated to be in fair condition. Telephone and data communication systems appear to be in fair condition.

- Abatement –** There is asbestos in this building. Asbestos is located in: tsi on pipes, fire retardent, plaster walls and ceilings, floor tile, etc.. There is lead based paint in this building.

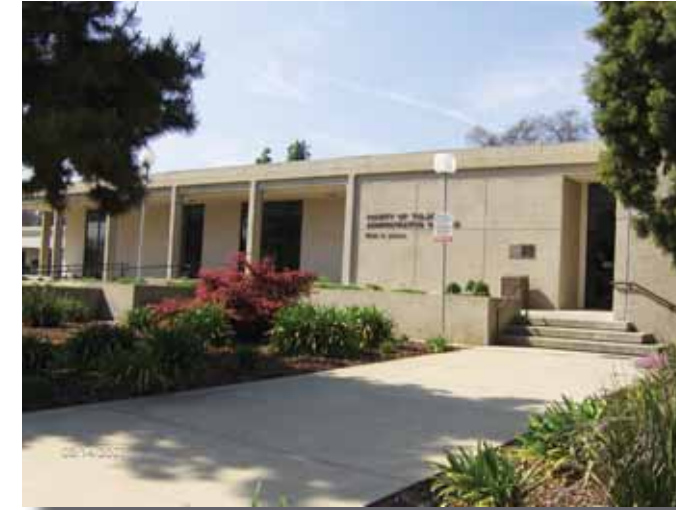
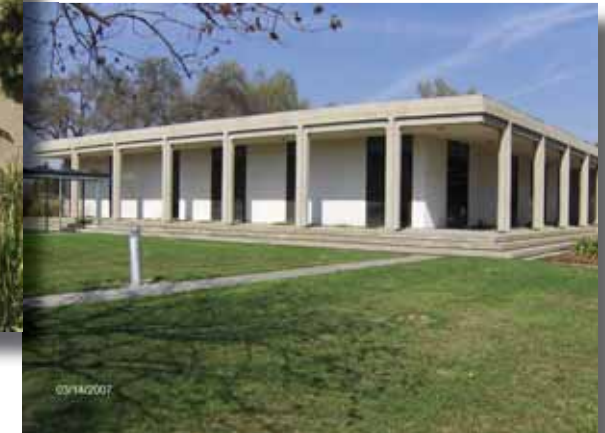
302 - Visalia Administration
2800 W. Burrel, Visalia

- General –** This facility is approximately 27 years old with a total size of 15162 gross square feet. The Building(s) is/are 1 story/stories tall and constructed of a/an Concrete and Steel Framed structure with a/an Slab on Grade floor diaphragm on a/an Conventional footings foundation. The exterior consists of Lath & Plaster and Exposed Concrete or CMU in good condition while the interior is wallboard, paint and wall covering in fair condition. The roof on this facility consists of built-up roofing, in poor condition, on a steel framing with topping slab structural roof system. The overall structural system is in good condition. The suspended acoustical, gypsum wallboard or plaster, and 12x12 tile ceiling is rated to be in fair condition and the carpet, vinyl composition tiles (VCT), ceramic tile, and exposed concrete floor is rated in fair condition.

- Fire & Life Safety –** The fire alarm system on this building is a/an Manual pull stations only with a/an Wet system, storage rooms only sprinkler system. The security system consists of None and is in (not rated or N/A) condition.

- HVAC –** The HVAC system in this building consists of a/an Central Plant with Boiler, Chiller, and Fan Coil Units that was installed 1980 and is rated to be in fair condition. The reported history of breakdowns on this system is: Has only happened once or twice

- Electrical –** The main electrical service (in amps) is 1000 amps with the last upgrade being unknown. The electrical power system is rated to be in fair condition and the electrical lighting is rated to be in fair condition. Telephone and data communication systems appear to be in fair condition.

- Abatement –** There may or may not be asbestos in this building. . There may or may not be lead based paint in this building.

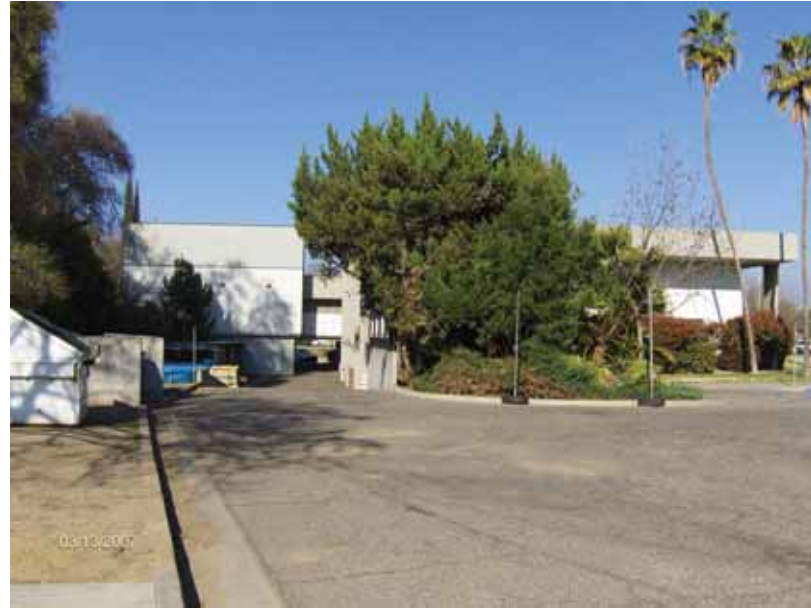
303 - Visalia Ag Building
2500 W. Burrel, Visalia, Ca.

- General –** This facility is approximately 38 years old with a total size of 24144 gross square feet. The Building(s) is/are 2 story/stories tall and constructed of a/an Concrete and Steel structure with a/an Slab on Grade floor diaphragm on a/an Conventional footings foundation. The exterior consists of Lath & Plaster, Exposed Concrete or CMU, and Metal Panels in good condition while the interior is wallboard with paint and wall covering in fair condition. The roof on this facility consists of built-up roofing, in good condition, on a steel framing with topping slab structural roof system. The overall structural system is in good condition. The suspended acoustical, gypsum wallboard or plaster, 12x12 tile, wood, and exposed structural ceiling is rated to be in fair condition and the carpet, vinyl composition tiles (VCT), ceramic tile, sheet vinyl, and exposed concrete floor is rated in fair condition.

- Fire & Life Safety –** The fire alarm system on this building is a/an Fully automatic with heat and smoke detectors with a/an Wet System, throughout building sprinkler system.
The security system consists of Door Alarms and Motion Sensors and is in good condition.

- HVAC –** The HVAC system in this building consists of a/an Central Plant with Boiler, Chiller, and Fan Coil Units that was installed 1970's and is rated to be in fair condition.
The reported history of breakdowns on this system is:
Has only happened once or twice

- Electrical –** The main electrical service (in amps) is unknown, 450 kva with the last upgrade being 2002. The electrical power system is rated to be in fair condition and the electrical lighting is rated to be in fair condition. Telephone and data communication systems appear to be in fair condition.

- Abatement –** There is asbestos in this building. Asbestos is located in: tsi pipe insulation, fire coating, plaster?.
There may or may not be lead based paint in this building.

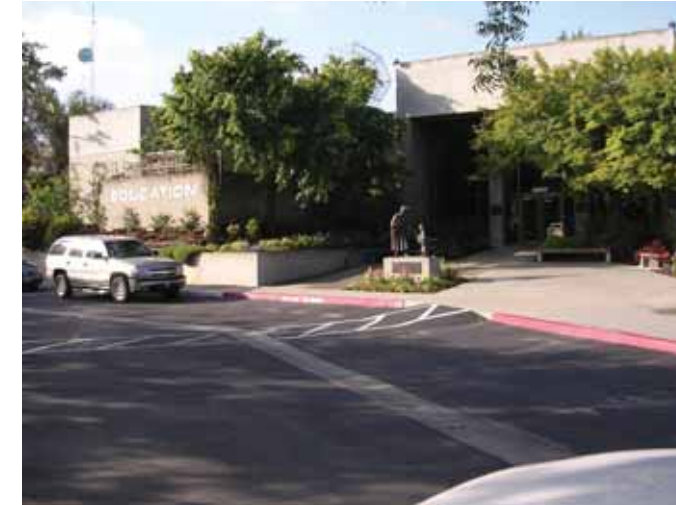
304 - Visalia Education Building
2637 W. Burrel, Visalia, Ca.

- General –** This facility is approximately 31 years old with a total size of 27380 gross square feet. The Building(s) is/are 2 story/stories tall and constructed of a/an Wood Framed, Concrete, and CMU structure with a/an Slab on Grade floor diaphragm on a/an Conventional footings foundation. The exterior consists of Lath & Plaster and Exposed Concrete or CMU in fair condition while the interior is wallboard with wall covering in fair condition. The roof on this facility consists of built-up roofing, in fair condition, on a wood framing structural roof system. The overall structural system is in fair condition. The suspended acoustical and gypsum wallboard or plaster ceiling is rated to be in fair condition and the carpet, vinyl composition tiles (VCT), ceramic tile, and exposed concrete floor is rated in fair condition.

- Fire & Life Safety –** The fire alarm system on this building is a/an Manual pull stations only with a/an None sprinkler system.
The security system consists of Door Alarms, Window Alarms, and Motion Sensors, and Security Cameras and is in good condition.

- HVAC –** The HVAC system in this building consists of a/an Package Units, Water Coolers, and Central Plant with Boiler, Chiller, and Fan Coil Units that was installed 1976 and is rated to be in fair condition.
The reported history of breakdowns on this system is:
Has only happened once or twice

- Electrical –** The main electrical service (in amps) is unknown with the last upgrade being unknown. The electrical power system is rated to be in fair condition and the electrical lighting is rated to be in fair condition. Telephone and data communication systems appear to be in fair condition.

- Abatement –** There may or may not be asbestos in this building. .
There may or may not be lead based paint in this building.

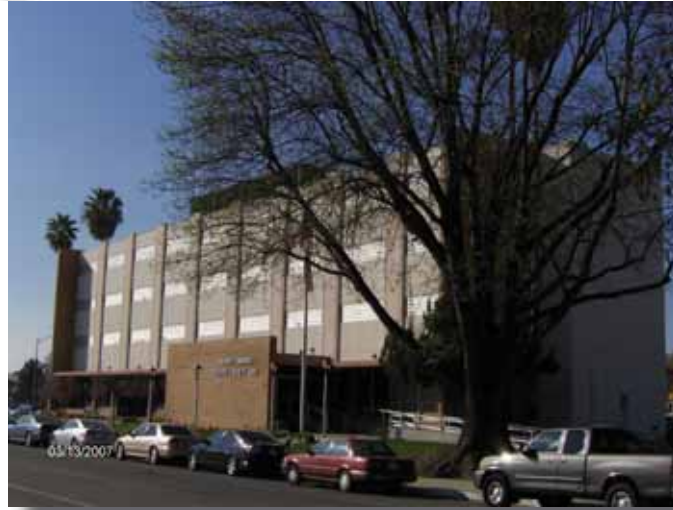
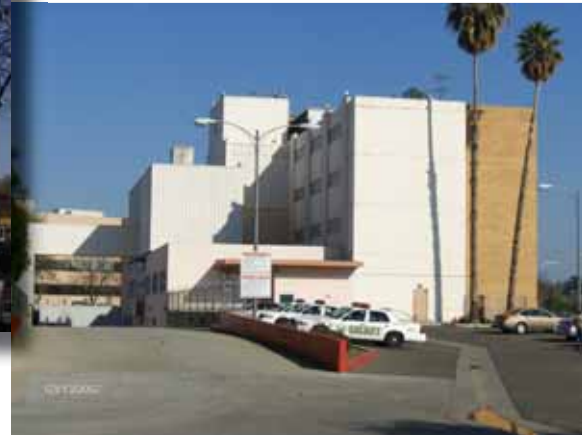
306 - Visalia Main Jail
2404 W. Burrel, Visalia, Ca.

General – This facility is approximately 46 years old with a total size of 57920 gross square feet. The Building(s) is/are 4 story/stories tall and constructed of a/an Concrete and Steel structure with a/an Slab on Grade floor diaphragm on a/an Conventional footings foundation. The exterior consists of Lath & Plaster, Exposed Concrete or CMU, Brick Veneer, and Metal Panels in fair condition while the interior is concrete/plaster paint in fair condition. The roof on this facility consists of built-up roofing, in fair condition, on a steel framing with topping slab structural roof system. The overall structural system is in fair condition. The suspended acoustical, gypsum wallboard or plaster, and exposed structural ceiling is rated to be in fair condition and the carpet, vinyl composition tiles (VCT), vinyl asbestos tiles (VAT), ceramic tile, and terrazzo floor is rated in fair condition.

Fire & Life Safety – The fire alarm system on this building is a/an Manual pull stations only with a/an Wet System, throughout building sprinkler system. The security system consists of Security Cameras and is in fair condition.

HVAC – The HVAC system in this building consists of a/an Data Air for Computer Room, Split A/C, Window AC Units and Central Plant with Boiler, Chiller, and Fan Coil Units that was installed 1961 thru 2003 and is rated to be in fair condition. The reported history of breakdowns on this system is: Has only happened once or twice

Electrical – The main electrical service (in amps) is 750 kva with the last upgrade being 2003, addition of co-gen. The electrical power system is rated to be in fair condition and the electrical lighting is rated to be in fair condition. Telephone and data communication systems appear to be in fair condition.

Abatement – There is asbestos in this building. Asbestos is located in: vat tile, plaster walls and ceilings, tsi on pipes. There is lead based paint in this building.

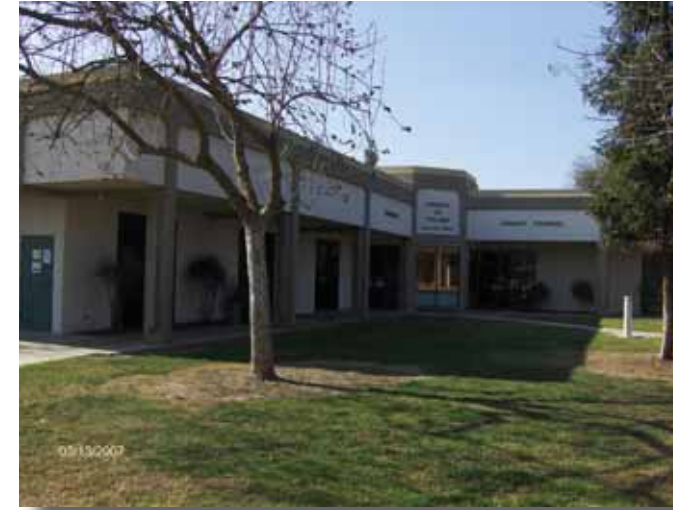
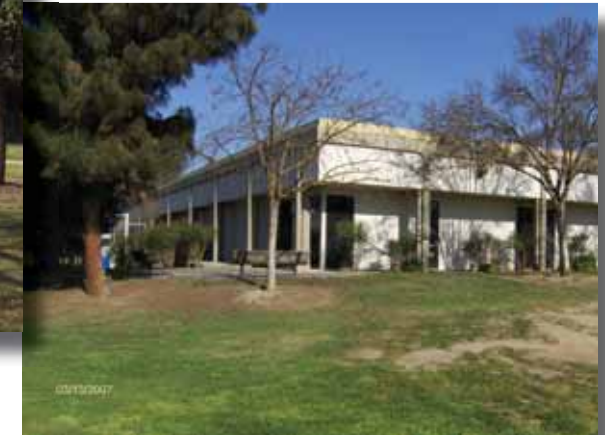
310 - County Counsel/ H.R.
2900 W. Burrel, Visalia, Ca.

General – This facility is approximately 21 years old with a total size of 16286 gross square feet. The Building(s) is/are 1 story/stories tall and constructed of a/an Steel structure with a/an Slab on Grade floor diaphragm on a/an Conventional footings foundation. The exterior consists of Lath & Plaster in fair condition while the interior is wallboard with paint and wall covering in fair condition. The roof on this facility consists of metal roofing, in fair condition, on a steel structure and metal roof system structural roof system. The overall structural system is in good condition. The suspended acoustical and gypsum wallboard or plaster ceiling is rated to be in fair condition and the carpet and ceramic tile floor is rated in fair condition.

Fire & Life Safety – The fire alarm system on this building is a/an Fully automatic with heat and smoke detectors with a/an Wet system, storage rooms only sprinkler system. The security system consists of Door Alarms and is in fair condition.

HVAC – The HVAC system in this building consists of a/an Central Plant with Boiler, Chiller, and Fan Coil Units that was installed 1986 and is rated to be in fair condition. The reported history of breakdowns on this system is: Has only happened once or twice

Electrical – The main electrical service (in amps) is 350 amps with the last upgrade being 1986. The electrical power system is rated to be in fair condition and the electrical lighting is rated to be in fair condition. Telephone and data communication systems appear to be in fair condition.

Abatement – There may or may not be asbestos in this building. . There may or may not be lead based paint in this building.

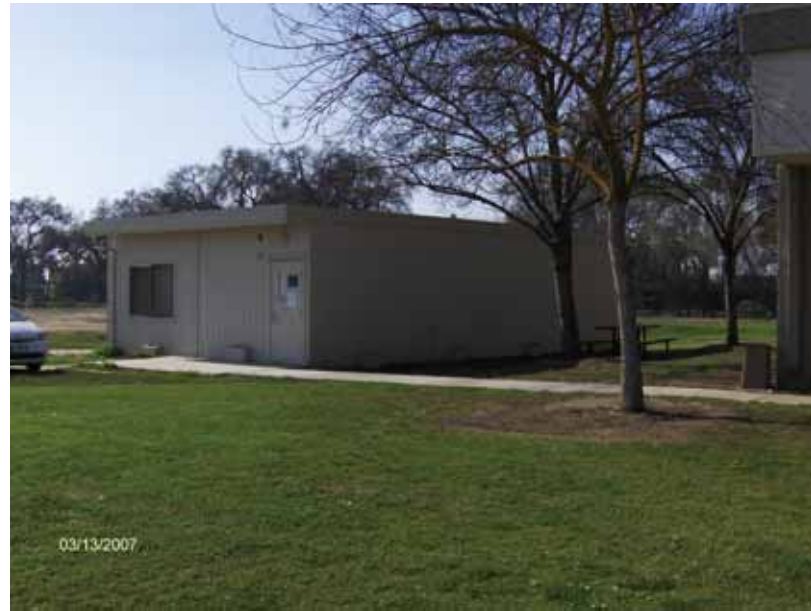
311 - H.R. Training Center
2900 W. Burrel, Visalia, Ca.

- General –** This facility is approximately 21 years old with a total size of 960 gross square feet. The Building(s) is/are 1 story/stories tall and constructed of a/an Wood Framed structure with a/an Wood framed floor diaphragm on a/an Unknown foundation. The exterior consists of Plywood in fair condition while the interior is panelling in fair condition. The roof on this facility consists of single ply roofing, in fair condition, on a wood framing structural roof system. The overall structural system is in fair condition. The suspended acoustical ceiling is rated to be in fair condition and the carpet floor is rated in fair condition.

- Fire & Life Safety –** The fire alarm system on this building is a/an Fully automatic with heat and smoke detectors with a/an None sprinkler system. The security system consists of Door Alarms, Window Alarms, and Motion Sensors and is in good condition.

- HVAC –** The HVAC system in this building consists of a/an Heat Pump that was installed 1986 and is rated to be in fair condition. The reported history of breakdowns on this system is: Has only happened once or twice

- Electrical –** The main electrical service (in amps) is 200 amps with the last upgrade being unknown. The electrical power system is rated to be in fair condition and the electrical lighting is rated to be in fair condition. Telephone and data communication systems appear to be in fair condition.

- Abatement –** There may or may not be asbestos in this building. . There may or may not be lead based paint in this building.

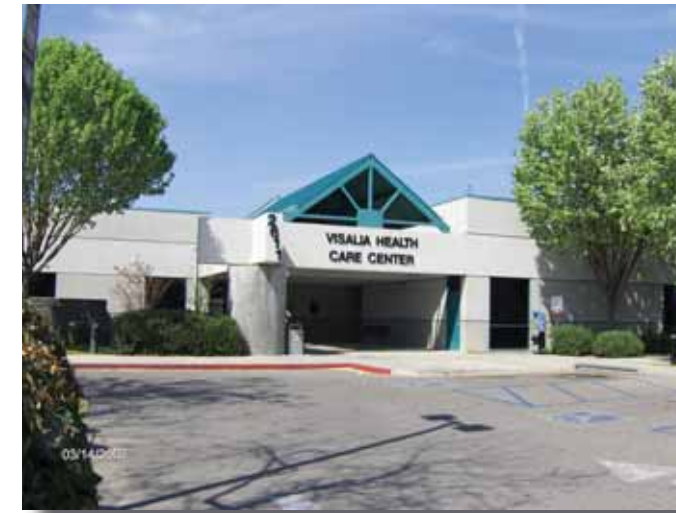
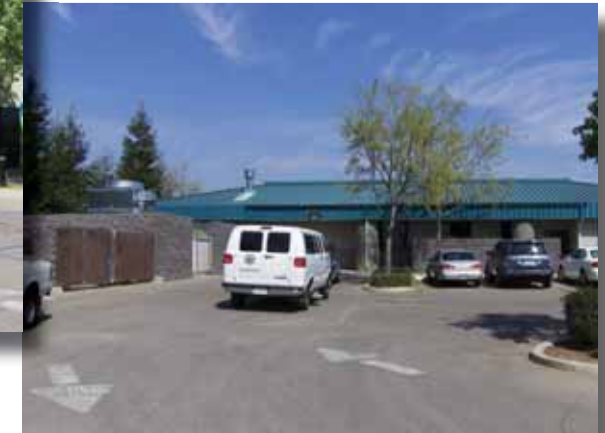
312 - Visalia Health Center
2611 No. Dinuba Blvd., Visalia, Ca.

- General –** This facility is approximately 11 years old with a total size of 24864 gross square feet. The Building(s) is/are 1 story/stories tall and constructed of a/an Concrete, Steel, and CMU structure with a/an Slab on Grade floor diaphragm on a/an Conventional footings foundation. The exterior consists of Lath & Plaster in fair condition while the interior is sheetrock with paint and wall covering in fair condition. The roof on this facility consists of built-up and metal roofing, in fair condition, on a wood framing structural roof system. The overall structural system is in good condition. The suspended acoustical and gypsum wallboard or plaster ceiling is rated to be in fair condition and the carpet, vinyl composition tiles (VCT), ceramic tile, and sheet vinyl floor is rated in fair condition.

- Fire & Life Safety –** The fire alarm system on this building is a/an Fully automatic with heat and smoke detectors with a/an Wet System, throughout building sprinkler system. The security system consists of None and is in (not rated or N/A) condition.

- HVAC –** The HVAC system in this building consists of a/an Central Plant with Boiler, Chiller, and Fan Coil Units that was installed 1995 and is rated to be in fair condition. The reported history of breakdowns on this system is: Has only happened once or twice

- Electrical –** The main electrical service (in amps) is 1000 amps with the last upgrade being 1995. The electrical power system is rated to be in fair condition and the electrical lighting is rated to be in fair condition. Telephone and data communication systems appear to be in fair condition.

- Abatement –** There may or may not be asbestos in this building. . There is not lead based paint in this building.

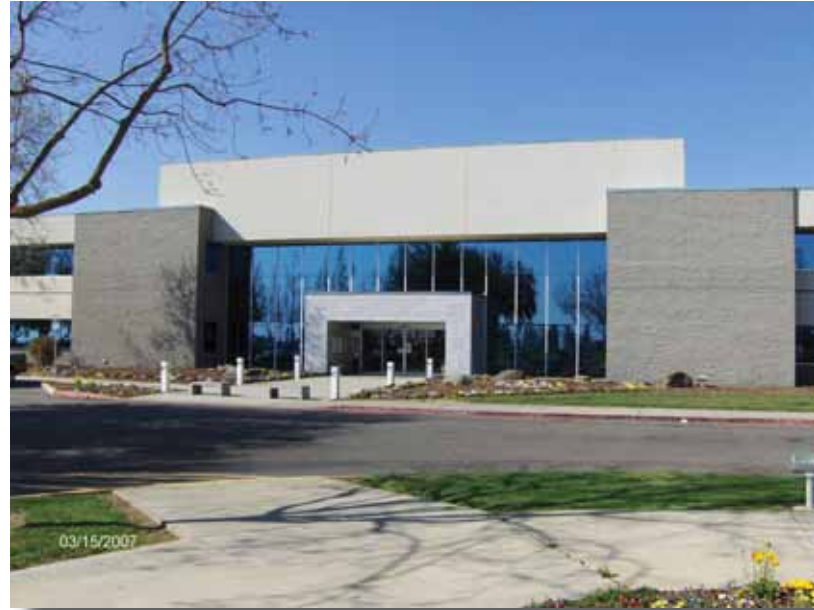
315 - Visalia Government Plaza
5957-5963 So. Mooney Blvd., Visalia

- General –** This facility is approximately 16 years old with a total size of 164621 gross square feet. The Building(s) is/are 2 story/stories tall and constructed of a/an Concrete and CMU structure with a/an Slab on Grade floor diaphragm on a/an Conventional footings foundation. The exterior consists of Exposed Concrete or CMU in fair condition while the interior is wallboard with paint in fair condition. The roof on this facility consists of single ply roofing, in fair condition, on a steel framing with topping slab structural roof system. The overall structural system is in good condition. The suspended acoustical ceiling is rated to be in fair condition and the carpet and ceramic tile floor is rated in fair condition.

- Fire & Life Safety –** The fire alarm system on this building is a/an Fully automatic with heat and smoke detectors with a/an Wet System, throughout building sprinkler system.
The security system consists of Security Cameras and card reader door locks and is in fair condition.

- HVAC –** The HVAC system in this building consists of a/an Split Systems and Central Plant with Boiler, Chiller, and Fan Coil Units that was installed 1992 and is rated to be in fair condition.
The reported history of breakdowns on this system is:
Has only happened once or twice

- Electrical –** The main electrical service (in amps) is 2500 amps with the last upgrade being unknown. The electrical power system is rated to be in fair condition and the electrical lighting is rated to be in fair condition. Telephone and data communication systems appear to be in good condition.

- Abatement –** There may or may not be asbestos in this building. .
There is not lead based paint in this building.
