SECTION 3.0 PRELIMINARY FACILITY CONDITION EVALUATION

3.0 Overview

3.1 Countywide Condition

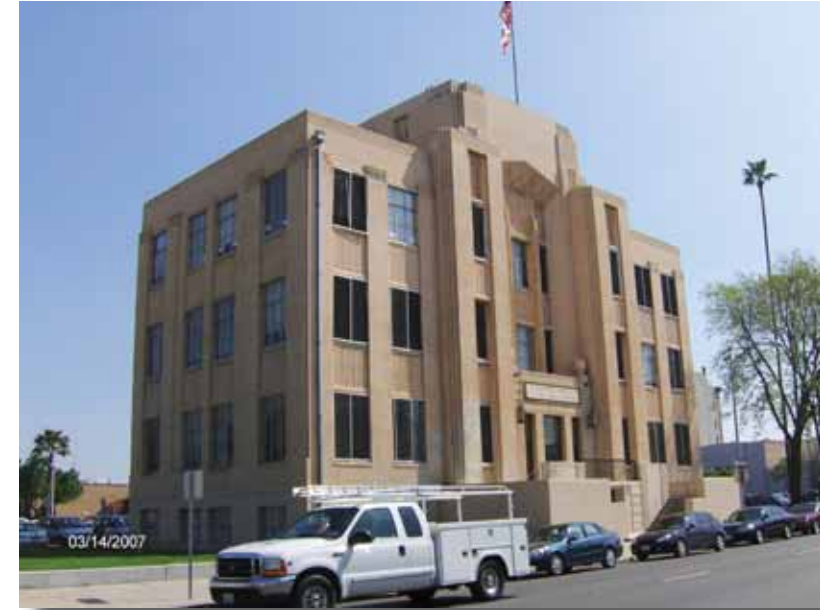
368 - Visalia DPSS
210 No. Court, Visalia, Ca.

- Electrical** – The main electrical service (in amps) is 400 amps with the last upgrade being 1975. The electrical power system is rated to be in fair condition and the electrical lighting is rated to be in fair condition. Telephone and data communication systems appear to be in fair condition.

- Abatement** – There is asbestos in this building. Asbestos is located in: tsi on pipes, plaster.
There is lead based paint in this building.

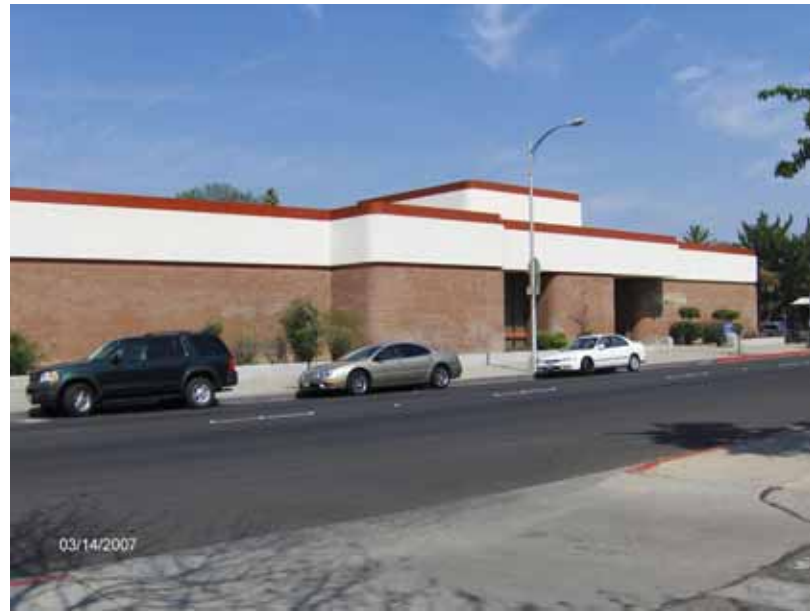
369 - Visalia DPSS Annex
100 E. Center, Visalia, Ca.

- Electrical –** The main electrical service (in amps) is 800 amps with the last upgrade being 1975. The electrical power system is rated to be in fair condition and the electrical lighting is rated to be in fair condition. Telephone and data communication systems appear to be in fair condition.

- Abatement –** There is asbestos in this building. Asbestos is located in: fire coating.
There may or may not be lead based paint in this building.

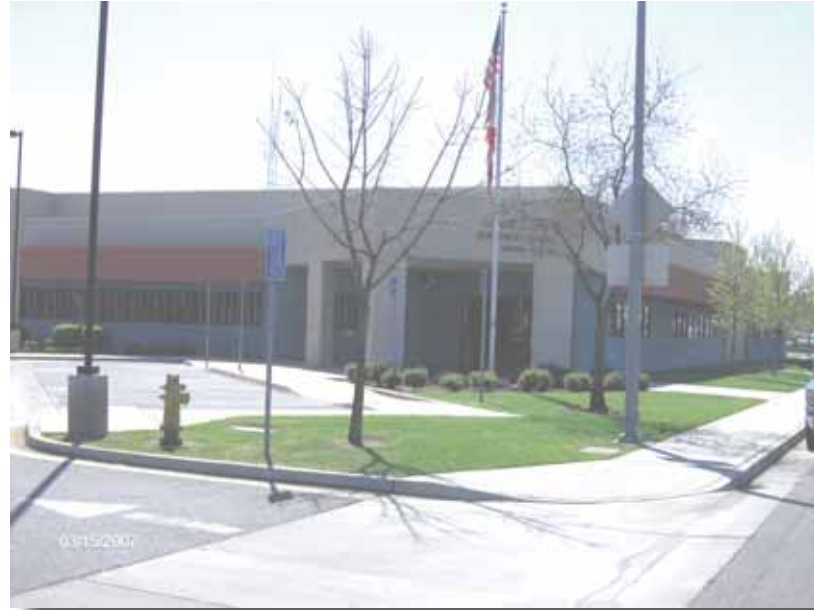
413 - Dinuba Justice Court (New)
640 So. Alta, Dinuba, Ca.

- Electrical** – The main electrical service (in amps) is 600 amps with the last upgrade being none. The electrical power system is rated to be in good condition and the electrical lighting is rated to be in good condition. Telephone and data communication systems appear to be in good condition.

- Abatement** – There is not asbestos in this building. .
There is not lead based paint in this building.

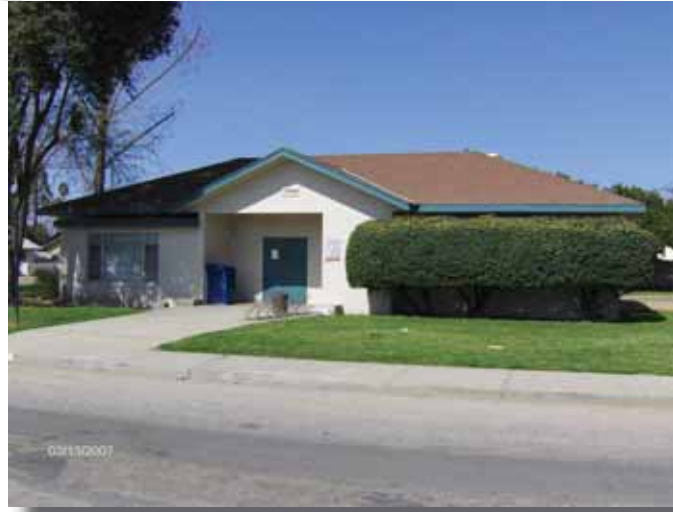
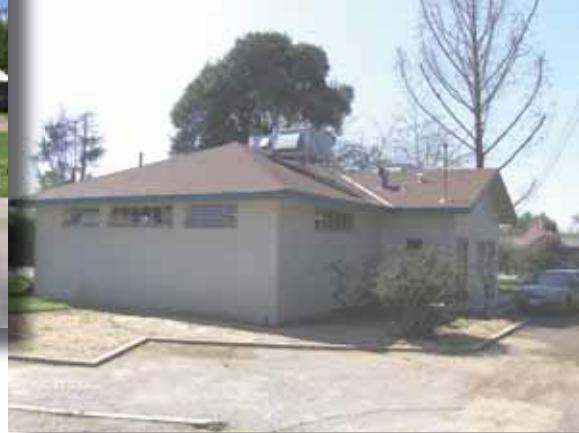
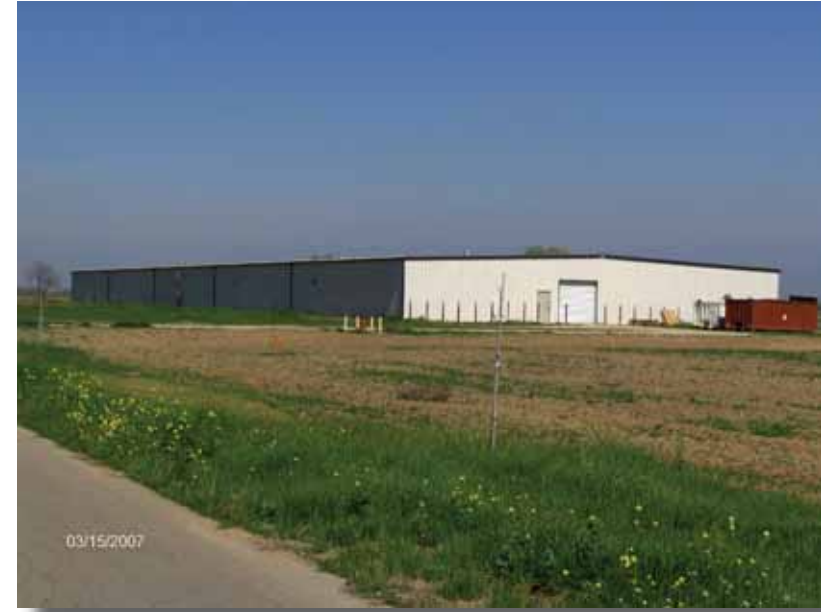
427 - Ivanhoe Library
15964 Heather, Ivanhoe, Ca.

General – This facility is approximately 56 years old with a total size of 2460 gross square feet. The Building(s) is/are 1 story/stories tall and constructed of a/an Wood Framed and CMU structure with a/an Slab on Grade floor diaphragm on a/an Conventional footings foundation. The exterior consists of Exposed Concrete or CMU in fair condition while the interior is plaster/paint in fair condition. The roof on this facility consists of composition shingle roofing, in fair condition, on a wood framing structural roof system. The overall structural system is in fair condition. The gypsum wallboard or plaster ceiling is rated to be in fair condition and the vinyl composition tiles (VCT) and vinyl asbestos tiles (VAT) floor is rated in fair condition.

Fire & Life Safety – The fire alarm system on this building is a/an None with a/an None sprinkler system. The security system consists of None and is in (not rated or N/A) condition.

HVAC – The HVAC system in this building consists of a/an Package Units that was installed 2003 and is rated to be in good condition. The reported history of breakdowns on this system is:
Never

Electrical – The main electrical service (in amps) is 225 amps with the last upgrade being unknown. The electrical power system is rated to be in fair condition and the electrical lighting is rated to be in fair condition. Telephone and data communication systems appear to be in fair condition.

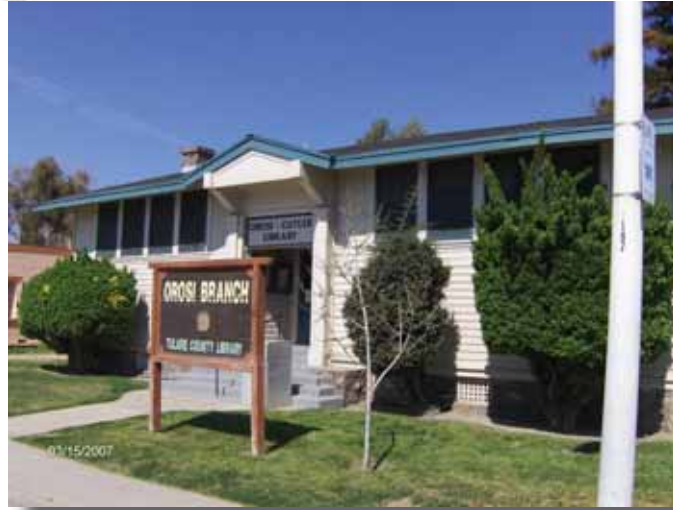
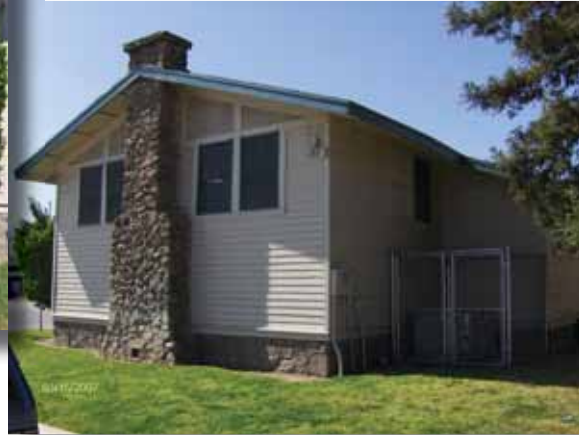
435 - Orosi Library
12646 Ave. 416, Orosi, Ca.

General – This facility is approximately 82 years old with a total size of 1494 gross square feet. The Building(s) is/are 1 story/stories tall and constructed of a/an Wood Framed structure with a/an Wood framed floor diaphragm on a/an rock foundation. The exterior consists of Lapped Wood Siding in fair condition while the interior is paint in fair condition. The roof on this facility consists of composition shingle roofing, in fair condition, on a wood framing structural roof system. The overall structural system is in fair condition. The ceiling is rated to be in fair condition and the vinyl composition tiles (VCT) and sheet vinyl floor is rated in fair condition.

Fire & Life Safety – The fire alarm system on this building is a/an None with a/an None sprinkler system. The security system consists of None and is in (not rated or N/A) condition.

HVAC – The HVAC system in this building consists of a/an Package Units that was installed 2000 and is rated to be in fair condition. The reported history of breakdowns on this system is:
Never

Electrical – The main electrical service (in amps) is 200 amps with the last upgrade being unknown. The electrical power system is rated to be in fair condition and the electrical lighting is rated to be in fair condition. Telephone and data communication systems appear to be in fair condition.

Abatement – There may or may not be asbestos in this building. .
There is lead based paint in this building.

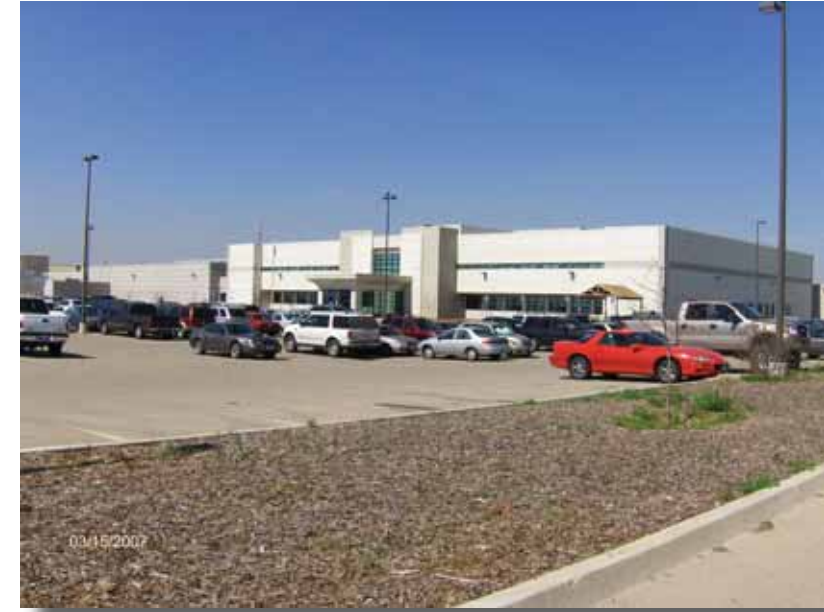
438 - Visalia Juvenile Justice Center
11120 Ave. 368, Visalia, Ca.

General – This facility is approximately 9 years old with a total size of 53181 gross square feet. The Building(s) is/are 2 story/stories tall and constructed of a/an Steel and CMU structure with a/an Slab on Grade floor diaphragm on a/an Conventional footings foundation. The exterior consists of Lath & Plaster in good condition while the interior is sheetrock/paint in fair condition. The roof on this facility consists of built-up roofing, in fair condition, on a steel framing with topping slab structural roof system. The overall structural system is in good condition. The suspended acoustical and exposed structural ceiling is rated to be in good condition and the carpet, vinyl composition tiles (VCT), ceramic tile, and quarry tile floor is rated in fair condition.

Fire & Life Safety – The fire alarm system on this building is a/an Fully automatic with heat and smoke detectors with a/an Wet System, throughout building sprinkler system. The security system consists of Security Cameras, Card Access, Metal Detectors, and Duress System and is in fair condition.

HVAC – The HVAC system in this building consists of a/an Central Plant with Boiler, Chiller, and Fan Coil Units that was installed 1997 and is rated to be in good condition. The reported history of breakdowns on this system is:
Has only happened once or twice

Electrical – The main electrical service (in amps) is 4000 amps for whole complex (inc. 442, 443, 432, and 438) with the last upgrade being 1997. The electrical power system is rated to be in good condition and the electrical lighting is rated to be in good condition. Telephone and data communication systems appear to be in good condition.

Abatement – There is not asbestos in this building. .
There is not lead based paint in this building.

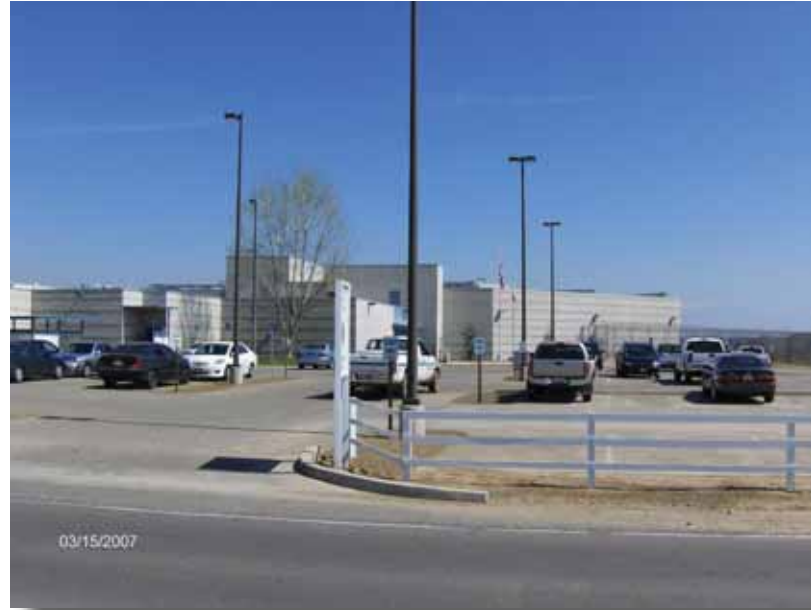
441 - Visalia Adult Pre-Sentencing Facility
36650 Road 112, Visalia, Ca.

- General –** This facility is approximately 8 years old with a total size of 134360 gross square feet. The Building(s) is/are 2 story/stories tall and constructed of a/an Concrete and CMU structure with a/an Slab on Grade floor diaphragm on a/an Conventional footings foundation. The exterior consists of Exposed Concrete or CMU in good condition while the interior is paint in fair condition. The roof on this facility consists of built-up roofing, in fair condition, on a steel framing with topping slab structural roof system. The overall structural system is in good condition. The suspended acoustical, gypsum wallboard or plaster, 12x12 tile, and exposed structural ceiling is rated to be in fair condition and the carpet, vinyl composition tiles (VCT), and ceramic tile floor is rated in fair condition.

- Fire & Life Safety –** The fire alarm system on this building is a/an Fully automatic with heat and smoke detectors with a/an Wet System, throughout building sprinkler system. The security system consists of Security Cameras and Electronic Door Locks and is in good condition.

- HVAC –** The HVAC system in this building consists of a/an Package Units that was installed 1997 and is rated to be in good condition. The reported history of breakdowns on this system is:
Has only happened once or twice

- Electrical –** The main electrical service (in amps) is 3000 amps with the last upgrade being 1997. The electrical power system is rated to be in good condition and the electrical lighting is rated to be in good condition. Telephone and data communication systems appear to be in good condition.

- Abatement –** There is not asbestos in this building. .
There is not lead based paint in this building.

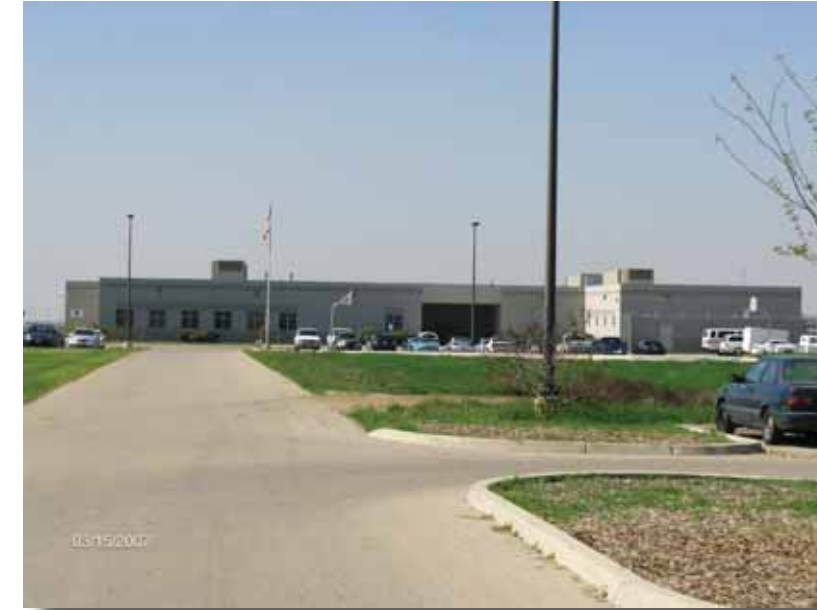
442 - Visalia Tulare County Youth Facility
11150 Ave. 368, Visalia, Ca.

- General –** This facility is approximately 9 years old with a total size of 39239 gross square feet. The Building(s) is/are 1 story/stories tall and constructed of a/an Concrete and Steel structure with a/an Slab on Grade floor diaphragm on a/an Conventional footings foundation. The exterior consists of Exposed Concrete or CMU in good condition while the interior is paint in good condition. The roof on this facility consists of built-up roofing, in fair condition, on a steel framing with topping slab structural roof system. The overall structural system is in good condition. The suspended acoustical ceiling is rated to be in good condition and the carpet and painted concrete floor is rated in fair condition.

- Fire & Life Safety –** The fire alarm system on this building is a/an Fully automatic with heat and smoke detectors with a/an Wet System, throughout building sprinkler system. The security system consists of Security Cameras and is in good condition.

- HVAC –** The HVAC system in this building consists of a/an Central Plant with Boiler, Chiller, and Fan Coil Units that was installed 1997 and is rated to be in good condition. The reported history of breakdowns on this system is:
Has only happened once or twice

- Electrical –** The main electrical service (in amps) is 4000 amps for whole complex (inc. 432, 438, 442 and 443) with the last upgrade being 1997. The electrical power system is rated to be in good condition and the electrical lighting is rated to be in good condition. Telephone and data communication systems appear to be in good condition.

- Abatement –** There is not asbestos in this building. .
There is not lead based paint in this building.

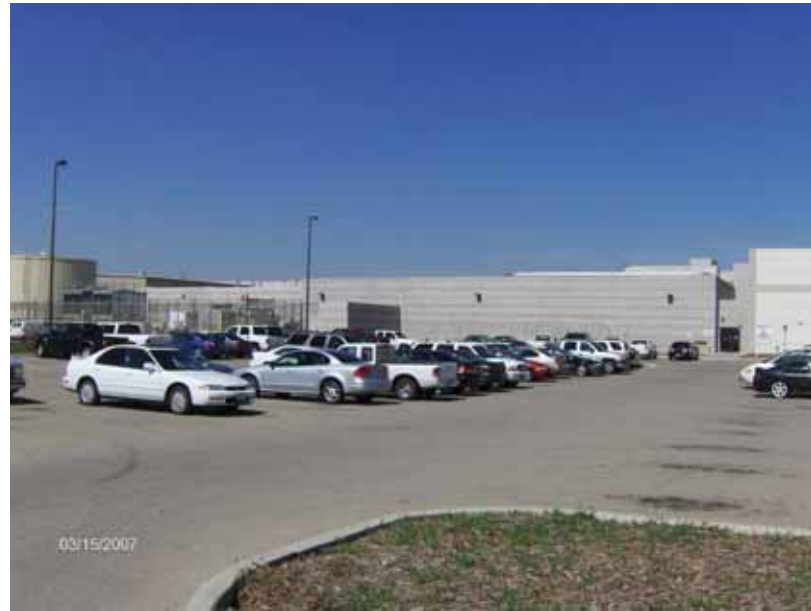
443 - Visalia Juvenile Justice Detention Facility
11120 Ave. 368, Visalia, Ca.

- General –** This facility is approximately 9 years old with a total size of 105788 gross square feet. The Building(s) is/are 2 story/stories tall and constructed of a/an CMU structure with a/an Slab on Grade floor diaphragm on a/an Conventional footings foundation. The exterior consists of Exposed Concrete or CMU and Metal Panels in good condition while the interior is paint in fair condition. The roof on this facility consists of built-up roofing, in fair condition, on a structural roof system. The overall structural system is in good condition. The suspended acoustical ceiling is rated to be in good condition and the carpet, ceramic tile, and exposed concrete floor is rated in fair condition.

- Fire & Life Safety –** The fire alarm system on this building is a/an Fully automatic with heat and smoke detectors with a/an Wet System, throughout building sprinkler system.
The security system consists of Security Cameras and Electronic Door Locks and is in good condition.

- HVAC –** The HVAC system in this building consists of a/an Central Plant with Boiler, Chiller, and Fan Coil Units that was installed 1997 and is rated to be in good condition.
The reported history of breakdowns on this system is:
Has only happened once or twice

- Electrical –** The main electrical service (in amps) is 4000 amps for whole complex (inc. 432, 438, 442 and 443) with the last upgrade being 1997. The electrical power system is rated to be in good condition and the electrical lighting is rated to be in good condition. Telephone and data communication systems appear to be in good condition.

- Abatement –** There is not asbestos in this building. .
There is not lead based paint in this building.

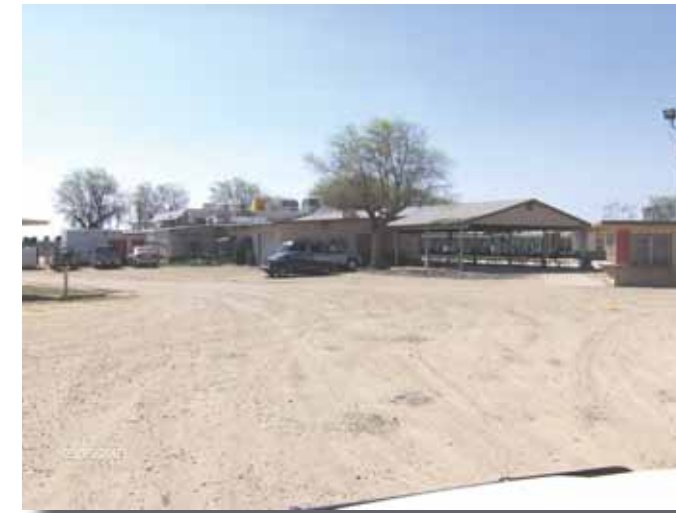
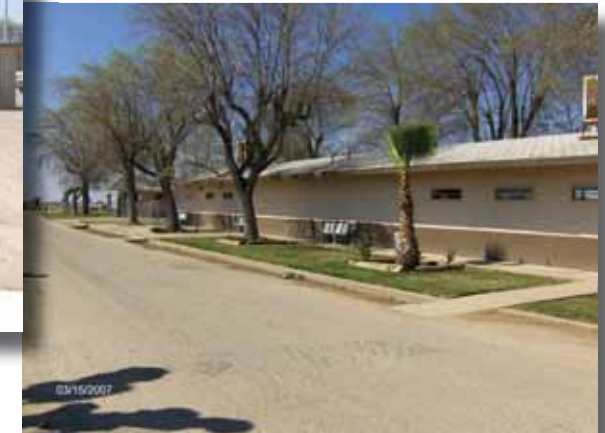
444 - Visalia Tulare County Correctional Facility
36000 Road 112, Visalia, Ca.

- General –** This facility is approximately 64 years old with a total size of 48910 gross square feet. The Building(s) is/are 1 story/stories tall and constructed of a/an Wood Framed structure with a/an Slab on Grade floor diaphragm on a/an Conventional footings foundation. The exterior consists of Lath & Plaster in fair condition while the interior is plaster/sheetrock with paint in fair condition. The roof on this facility consists of composition shingle and single ply roofing, in poor condition, on a wood framing structural roof system. The overall structural system is in fair condition. The suspended acoustical, gypsum wallboard or plaster, and exposed structural ceiling is rated to be in fair condition and the carpet, vinyl composition tiles (VCT), vinyl asbestos tiles (VAT), ceramic tile, and exposed concrete floor is rated in poor condition.

- Fire & Life Safety –** The fire alarm system on this building is a/an Fully automatic with heat and smoke detectors with a/an None sprinkler system.
The security system consists of None and is in (not rated or N/A) condition.

- HVAC –** The HVAC system in this building consists of a/an Package Units, Window AC Units, Gas Furnace, and Water Coolers that was installed "varies per building, package units 2003" and is rated to be in fair condition.
The reported history of breakdowns on this system is:
Has only happened once or twice

- Electrical –** The main electrical service (in amps) is 400 amps with the last upgrade being 2003. The electrical power system is rated to be in fair condition and the electrical lighting is rated to be in fair condition. Telephone and data communication systems appear to be in fair condition.

- Abatement –** There is asbestos in this building. Asbestos is located in: vat, sheetrock, tsi on pipes, joint compound and some window glazing.
There is lead based paint in this building.

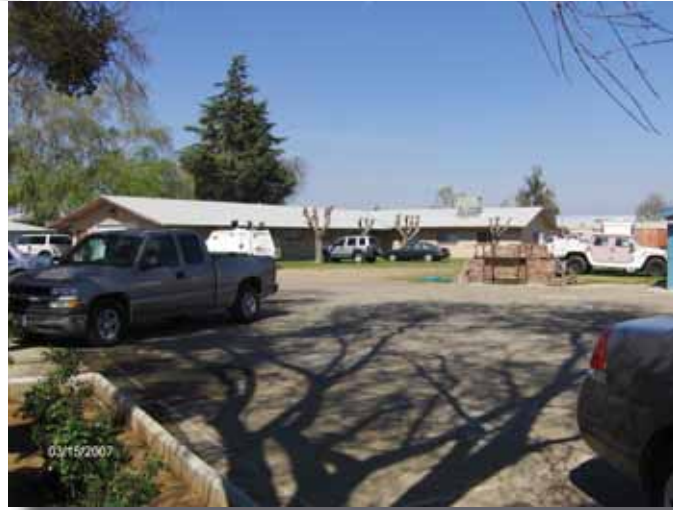
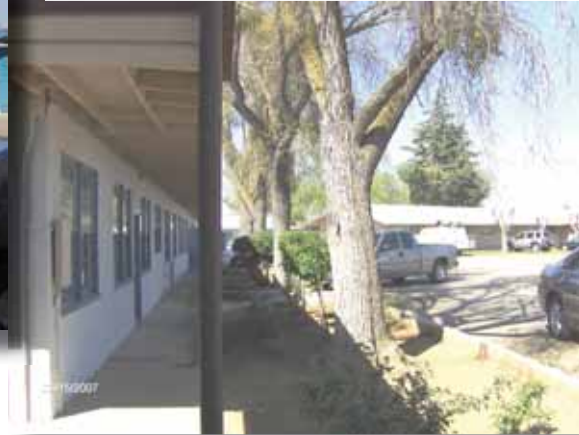
445 - Visalia Robert K Myers Boys Camp
36008 Road 112, Visalia, Ca.

General – This facility is approximately 46 years old with a total size of 25975 gross square feet. The Building(s) is/are 1 story/stories tall and constructed of a/an Wood Framed structure with a/an Slab on Grade floor diaphragm on a/an Conventional footings foundation. The exterior consists of Lath & Plaster and Exposed Concrete or CMU in fair condition while the interior is plaster/paint in fair condition. The roof on this facility consists of built-up and composition shingle roofing, in fair condition, on a wood framing structural roof system. The overall structural system is in fair condition. The suspended acoustical, gypsum wallboard or plaster, and 12x12 tile ceiling is rated to be in fair condition and the carpet, vinyl composition tiles (VCT) floor is rated in fair condition.

Fire & Life Safety – The fire alarm system on this building is a/an None with a/an None sprinkler system. The security system consists of Door Alarms and is in good condition.

HVAC – The HVAC system in this building consists of a/an Package Units that was installed 2003 and is rated to be in good condition. The reported history of breakdowns on this system is: Has only happened once or twice

Electrical – The main electrical service (in amps) is 200 amps with the last upgrade being unknown. The electrical power system is rated to be in fair condition and the electrical lighting is rated to be in fair condition. Telephone and data communication systems appear to be in fair condition.

Abatement – There may or may not be asbestos in this building. .
There may or may not be lead based paint in this building.

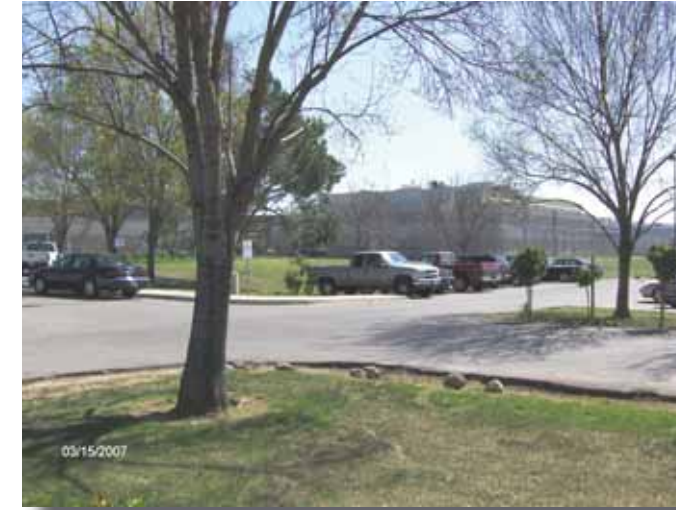
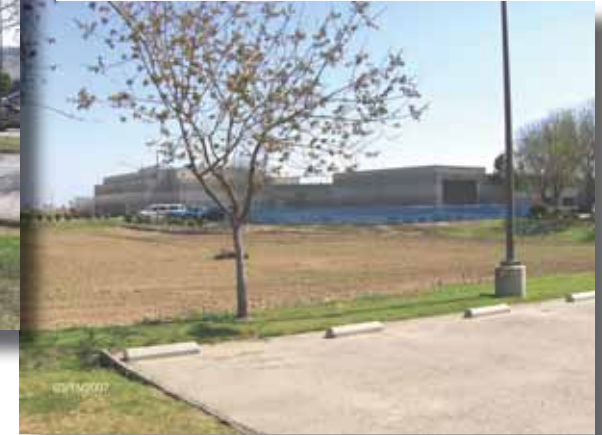
446 - Bob Wiley Detention Facility
36712 Road 112, Visalia, Ca.

General – This facility is approximately 26 years old with a total size of 130564 gross square feet. The Building(s) is/are 2 story/stories tall and constructed of a/an Concrete and Steel structure with a/an Slab on Grade floor diaphragm on a/an Conventional footings foundation. The exterior consists of Exposed Concrete or CMU in fair condition while the interior is concrete block/paint in fair condition. The roof on this facility consists of built-up roofing, in fair condition, on a steel framing with topping slab structural roof system. The overall structural system is in fair condition. The suspended acoustical, gypsum wallboard or plaster, and exposed structural ceiling is rated to be in fair condition and the carpet, vinyl composition tiles (VCT), ceramic tile, quarry tile, sheet vinyl, and exposed concrete floor is rated in fair condition.

Fire & Life Safety – The fire alarm system on this building is a/an Fully automatic with heat and smoke detectors with a/an Wet System, throughout building sprinkler system. The security system consists of Security Cameras and Electronic Door Locks and is in fair condition.

HVAC – The HVAC system in this building consists of a/an Central Plant with Boiler, Chiller, and Fan Coil Units that was installed 1986 and is rated to be in fair condition. The reported history of breakdowns on this system is: Has only happened once or twice

Electrical – The main electrical service (in amps) is 3000 amps with the last upgrade being not provided. The electrical power system is rated to be in fair condition and the electrical lighting is rated to be in good condition. Telephone and data communication systems appear to be in fair condition.

Abatement – There may or may not be asbestos in this building. .
There may or may not be lead based paint in this building.

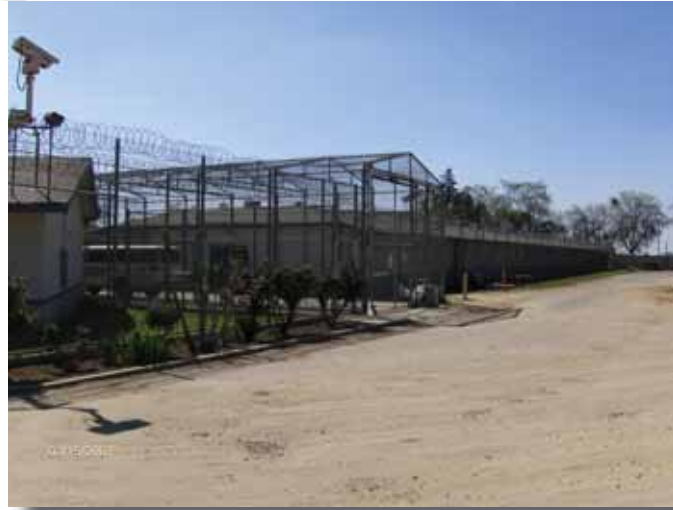
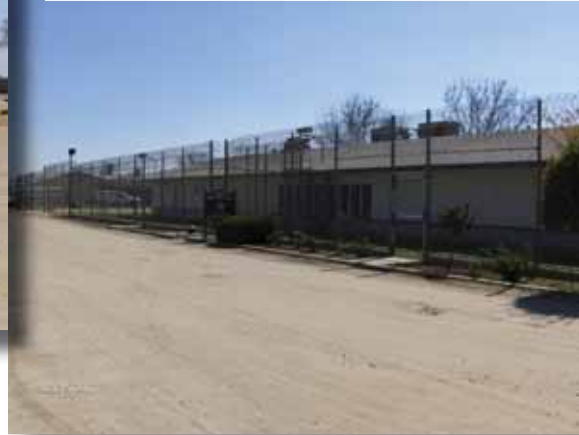
447 - Mens Correctional Facility
36168 Road 112, Visalia, Ca.

- Fire & Life Safety –** The fire alarm system on this building is a/an Fully automatic with heat and smoke detectors with a/an Wet System, throughout building sprinkler system.
The security system consists of Door Alarms and Security Cameras and is in good condition.

- Electrical –** The main electrical service (in amps) is 200 amps with the last upgrade being 1999. The electrical power system is rated to be in fair condition and the electrical lighting is rated to be in fair condition. Telephone and data communication systems appear to be in fair condition.

- Abatement –** There may or may not be asbestos in this building. .
There may or may not be lead based paint in this building.

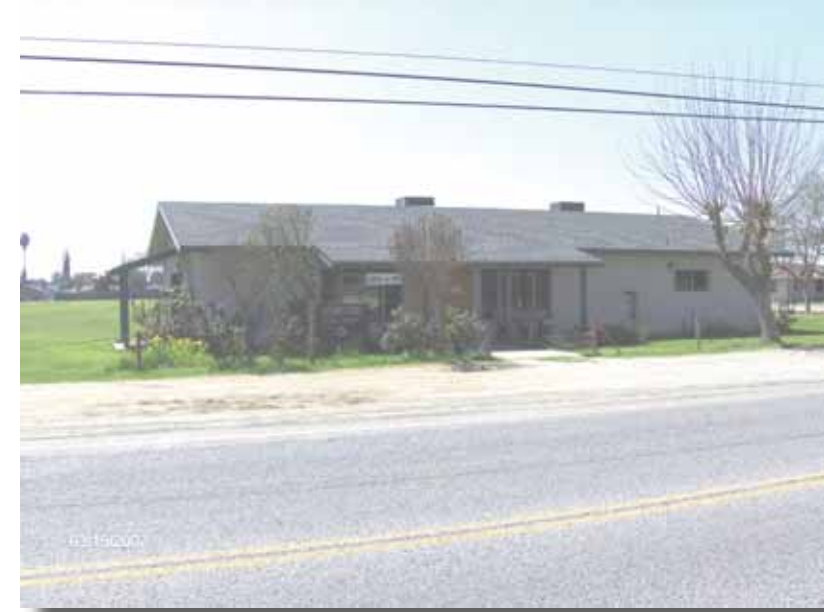
490 - Cutler/Orosi Senior Center
12691 Ave. 408, Cutler, Ca.

- Electrical –** The main electrical service (in amps) is 200 amps with the last upgrade being unknown. The electrical power system is rated to be in fair condition and the electrical lighting is rated to be in fair condition. Telephone and data communication systems appear to be in fair condition.

- Abatement –** There may or may not be asbestos in this building. .
There may or may not be lead based paint in this building.

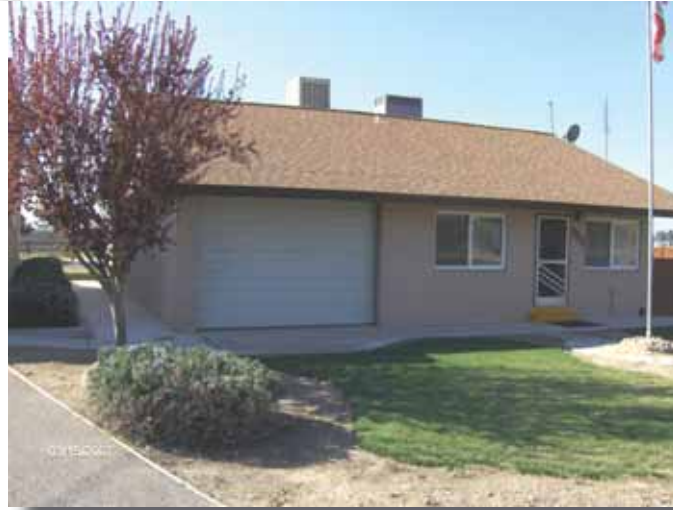
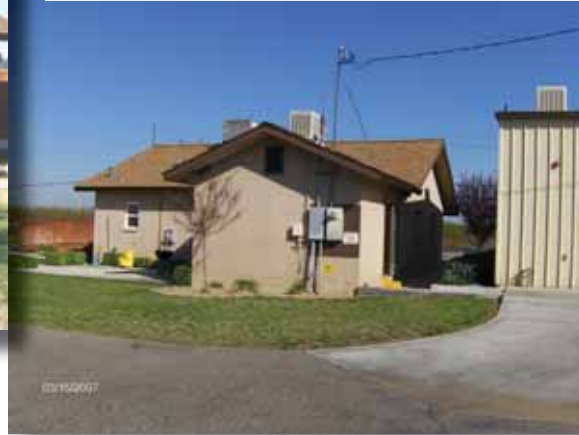
493 - Kings River Fire Station
3811 Ave. 400

Electrical – The main electrical service (in amps) is 200 with the last upgrade being unknown. The electrical power system is rated to be in fair condition and the electrical lighting is rated to be in fair condition. Telephone and data communication systems appear to be in fair condition.

Abatement – There may or may not be asbestos in this building. .
There may or may not be lead based paint in this building.

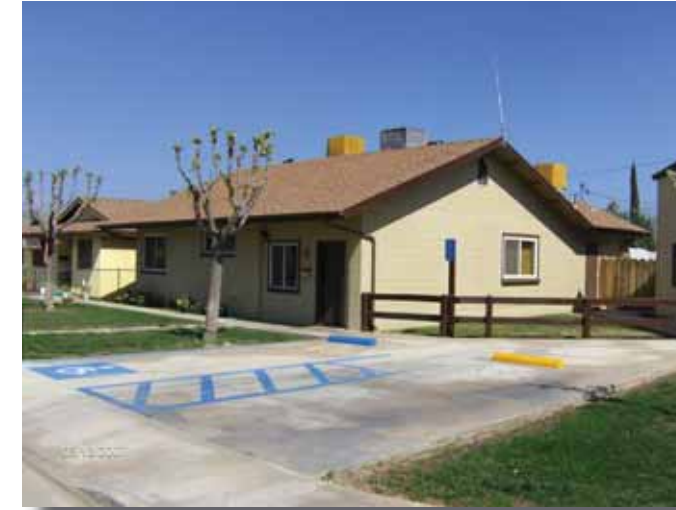
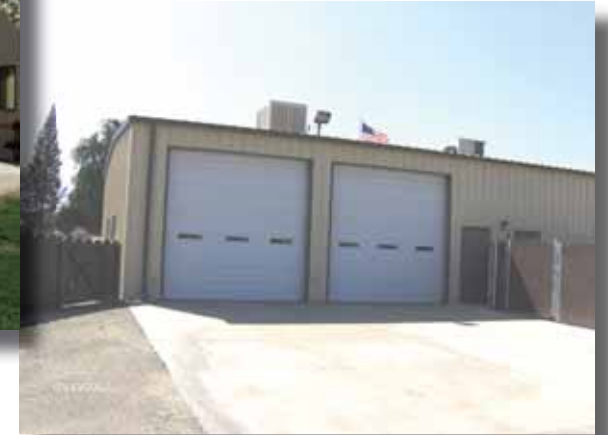
494 - Ivanhoe Fire Station
32868 Hawthorne Road, Ivanhoe

Electrical – The main electrical service (in amps) is 200/50's with the last upgrade being unknown. The electrical power system is rated to be in good condition and the electrical lighting is rated to be in good condition. Telephone and data communication systems appear to be in fair condition.

Abatement – There may or may not be asbestos in this building. .
There may or may not be lead based paint in this building.

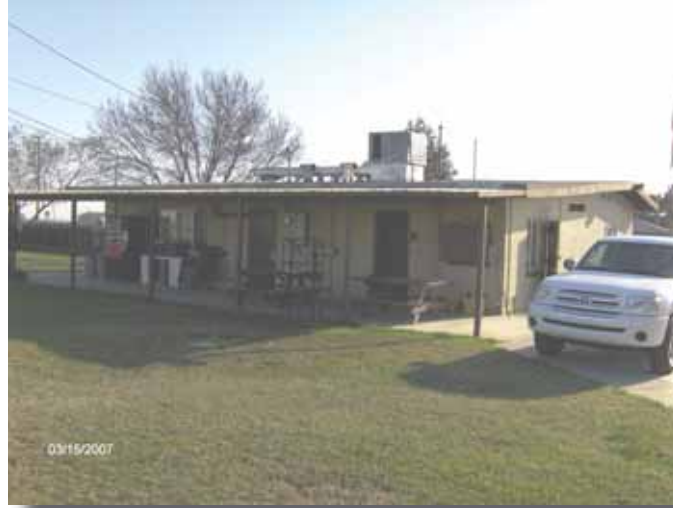
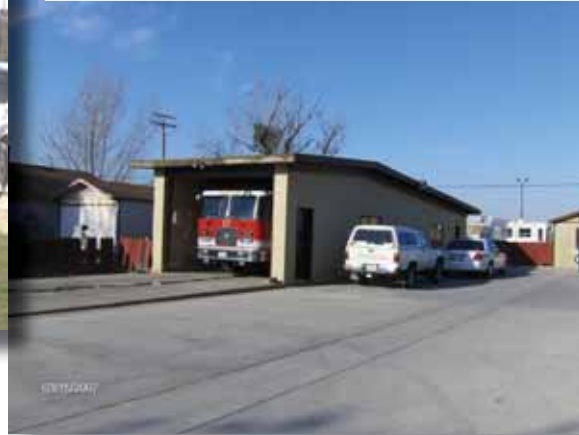
495 - Goshen Fire Station
30901 Road 67, Goshen

Electrical – The main electrical service (in amps) is 200 with the last upgrade being 5-6 yrs ago. The electrical power system is rated to be in good condition and the electrical lighting is rated to be in fair condition. Telephone and data communication systems appear to be in fair condition.

Abatement – There may or may not be asbestos in this building.
Older building, maybe.
There may or may not be lead based paint in this building.

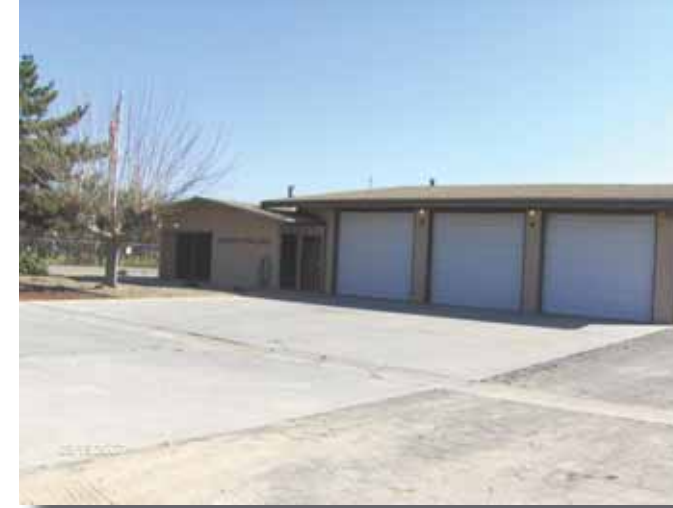
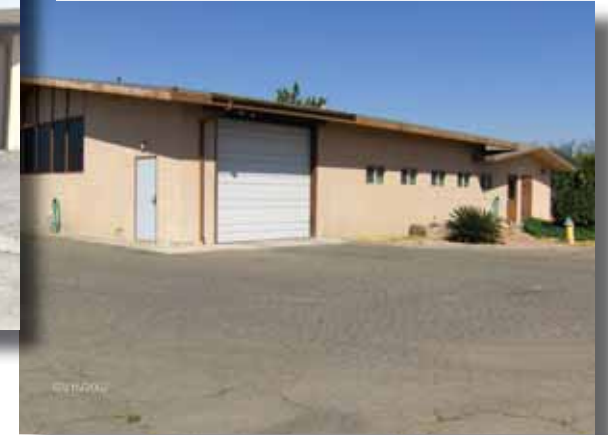
497 - Dinuba Fire Station
40404 Road 80, Dinuba

Electrical – The main electrical service (in amps) is "building locked - unknown" with the last upgrade being . The electrical power system is rated to be in condition and the electrical lighting is rated to be in fair condition. Telephone and data communication systems appear to be in condition.

Abatement – There may or may not be asbestos in this building. .
There may or may not be lead based paint in this building.

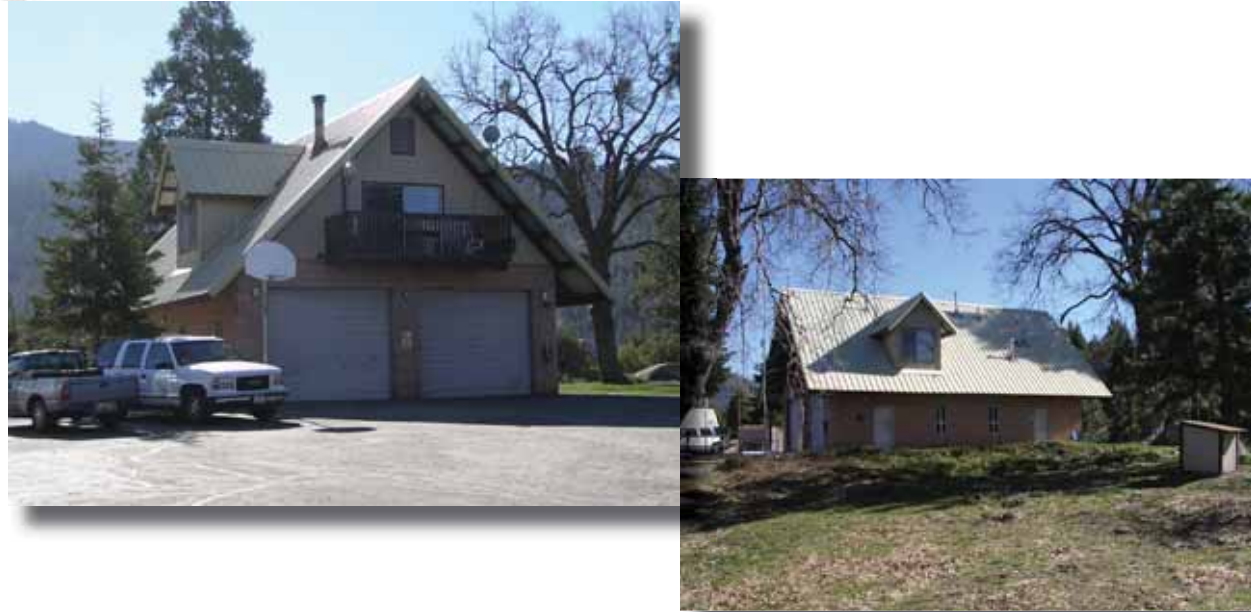
239 - Poso Fire Station
45656 Old Stage Drive, Posey, Ca.

- Electrical –** The main electrical service (in amps) is 200 amps with the last upgrade being unknown. The electrical power system is rated to be in good condition and the electrical lighting is rated to be in fair condition. Telephone and data communication systems appear to be in fair condition.

- Abatement –** There may or may not be asbestos in this building. .
There may or may not be lead based paint in this building.

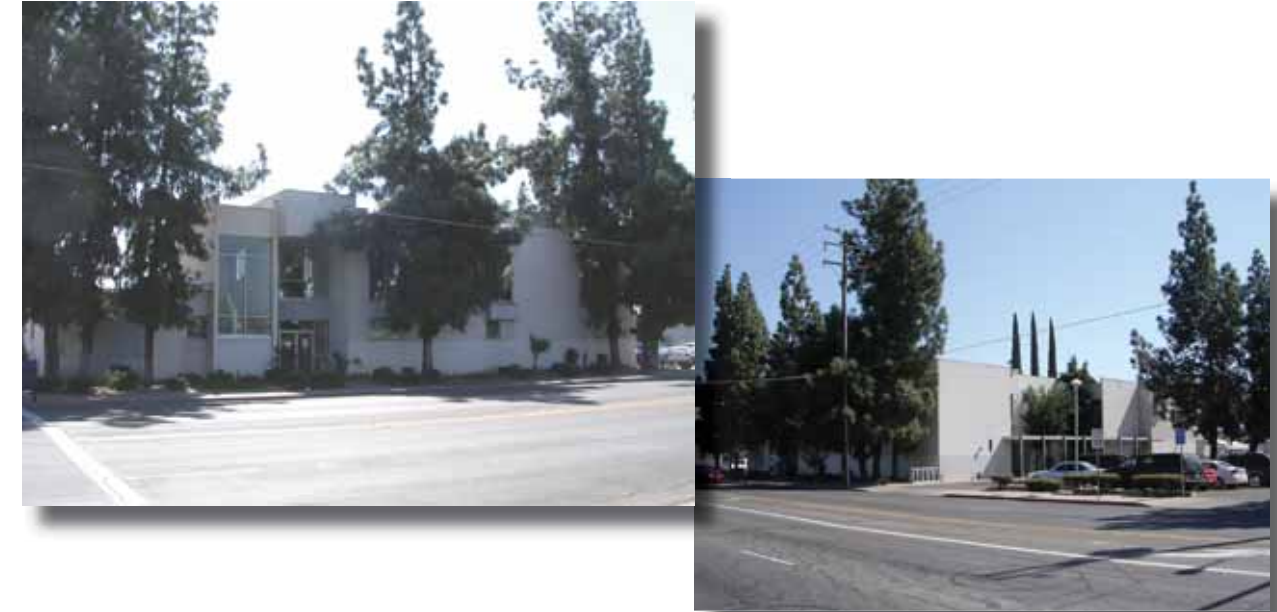
539 - Porterville Gov't Center - Superior Court
87 E. Morton, Porterville, Ca.

- Electrical –** The main electrical service (in amps) is 1000 amps with the last upgrade being unknown. The electrical power system is rated to be in fair condition and the electrical lighting is rated to be in fair condition. Telephone and data communication systems appear to be in fair condition.

- Abatement –** There may or may not be asbestos in this building. .
There may or may not be lead based paint in this building.

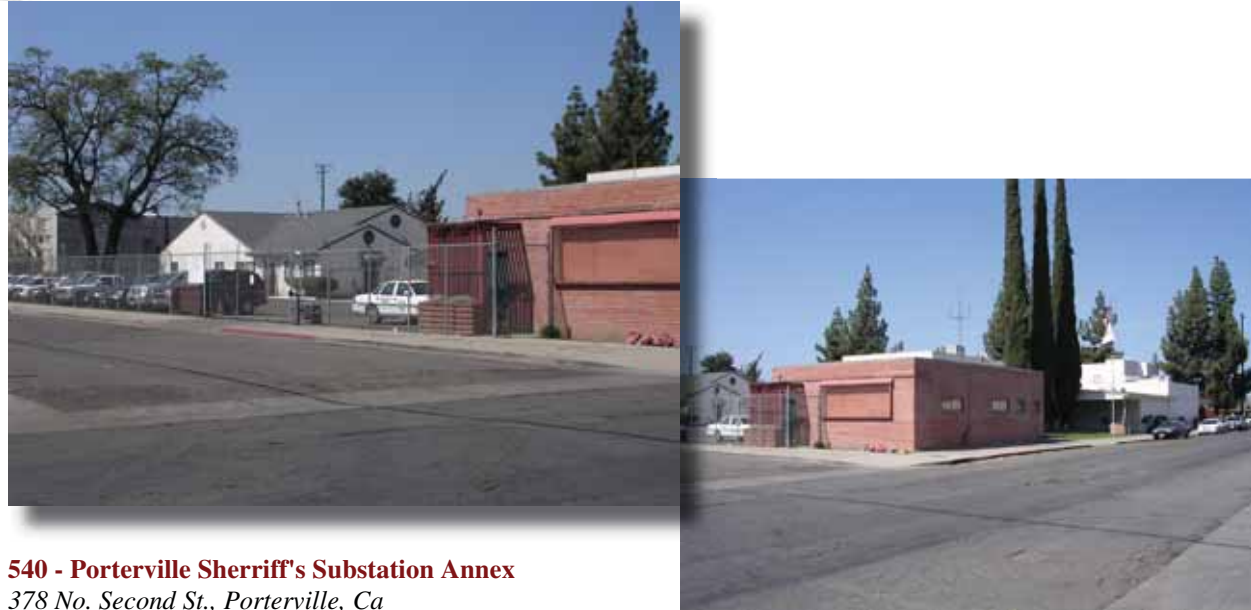
540 - Porterville Sherriff's Substation Annex
378 No. Second St., Porterville, Ca

- General –** This facility is approximately 46 years old with a total size of 8723 gross square feet. The Building(s) is/are 1 story/stories tall and constructed of a/an Wood Framed and CMU structure with a/an Slab on Grade floor diaphragm on a/an Conventional footings foundation. The exterior consists of Lath & Plaster, Exposed Concrete or CMU in fair condition while the interior is plaster/paint in fair condition. The roof on this facility consists of composition shingle and built-up roofing, in fair condition, on a wood framing structural roof system. The overall structural system is in fair condition. The gypsum wallboard or plaster ceiling is rated to be in fair condition and the carpet and vinyl composition tiles (VCT) floor is rated in fair condition.

- Electrical –** The main electrical service (in amps) is 200 amps with the last upgrade being unknown. The electrical power system is rated to be in fair condition and the electrical lighting is rated to be in fair condition. Telephone and data communication systems appear to be in fair condition.

- Abatement –** There is asbestos in this building. Asbestos is located in: vat. There may or may not be lead based paint in this building.

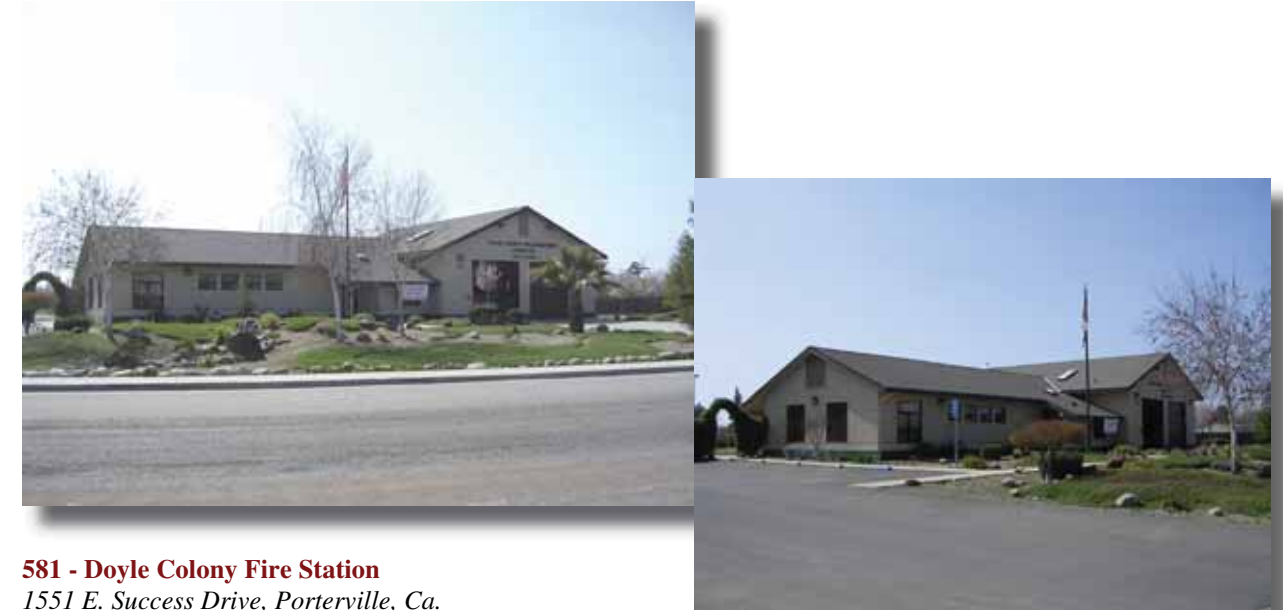
581 - Doyle Colony Fire Station
1551 E. Success Drive, Porterville, Ca.

- General –** This facility is approximately 13 years old with a total size of 4000 gross square feet. The Building(s) is/are 1 story/stories tall and constructed of a/an Steel structure with a/an Slab on Grade floor diaphragm on a/an Conventional footings foundation. The exterior consists of Lath & Plaster in good condition while the interior is sheetrock/paint in good condition. The roof on this facility consists of composition shingle roofing, in fair condition, on a wood framing structural roof system. The overall structural system is in good condition. The suspended acoustical and gypsum wallboard or plaster ceiling is rated to be in good condition and the carpet, vinyl composition tiles (VCT), ceramic tile, and sheet vinyl floor is rated in fair condition.

- Electrical –** The main electrical service (in amps) is 200 amps with the last upgrade being unknown. The electrical power system is rated to be in good condition and the electrical lighting is rated to be in good condition. Telephone and data communication systems appear to be in good condition.

- Abatement –** There is not asbestos in this building. . There is not lead based paint in this building.

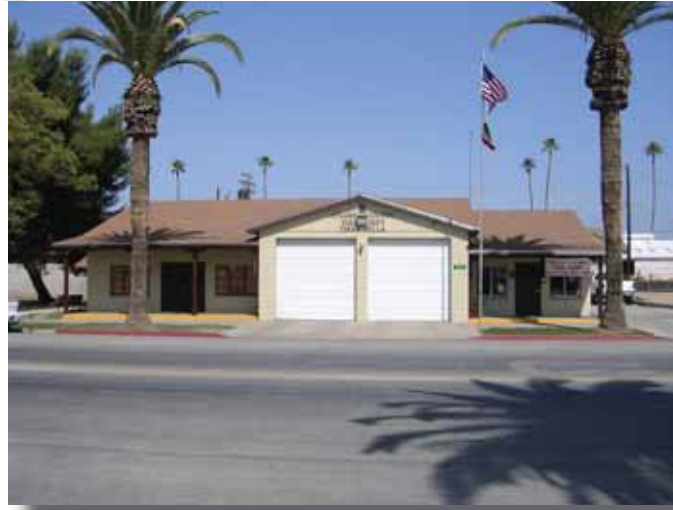
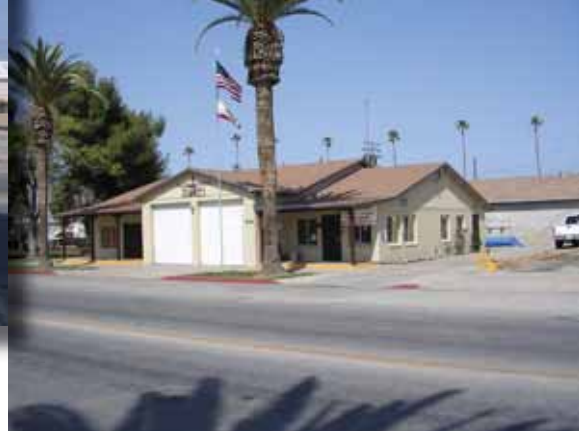
588 - Terra Bella Fire Station
23656 Ave. 95, Terra Bella, Ca.

General – This facility is approximately 46 years old with a total size of 3064 gross square feet. The Building(s) is/are 1 story/stories tall and constructed of a/an Wood Framed and CMU structure with a/an Slab on Grade floor diaphragm on a/an Conventional footings foundation. The exterior consists of Lath & Plaster, Exposed Concrete or CMU, and Plywood in good condition while the interior is plaster/paint in fair condition. The roof on this facility consists of composition shingle roofing, in good condition, on a wood framing structural roof system. The overall structural system is in fair condition. The gypsum wallboard or plaster ceiling is rated to be in good condition and the carpet and sheet vinyl floor is rated in fair condition.

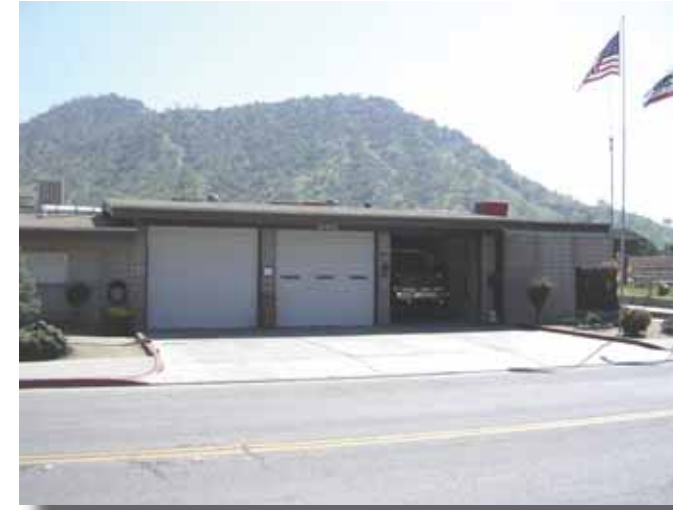
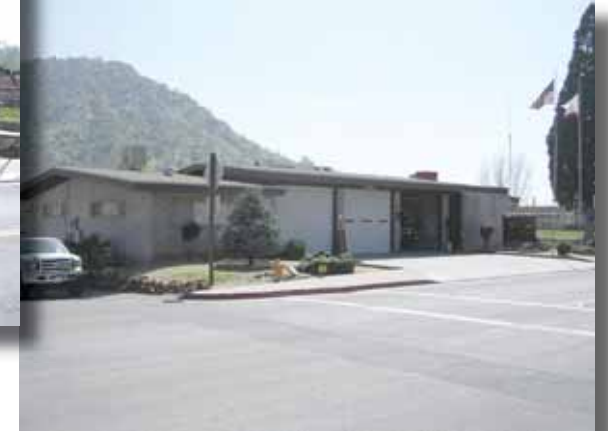
Fire & Life Safety – The fire alarm system on this building is a/an None with a/an None sprinkler system. The security system consists of None and is in (not rated or N/A) condition.

HVAC – The HVAC system in this building consists of a/an Package Units that was installed 2000 and is rated to be in good condition. The reported history of breakdowns on this system is:
Never

Electrical – The main electrical service (in amps) is 100 amps with the last upgrade being unknown. The electrical power system is rated to be in fair condition and the electrical lighting is rated to be in fair condition. Telephone and data communication systems appear to be in fair condition.

Abatement – There may or may not be asbestos in this building. .
There may or may not be lead based paint in this building.
