SECTION 3.0 PRELIMINARY FACILITY CONDITION EVALUATION

3.0 Overview

3.1 Countywide Condition

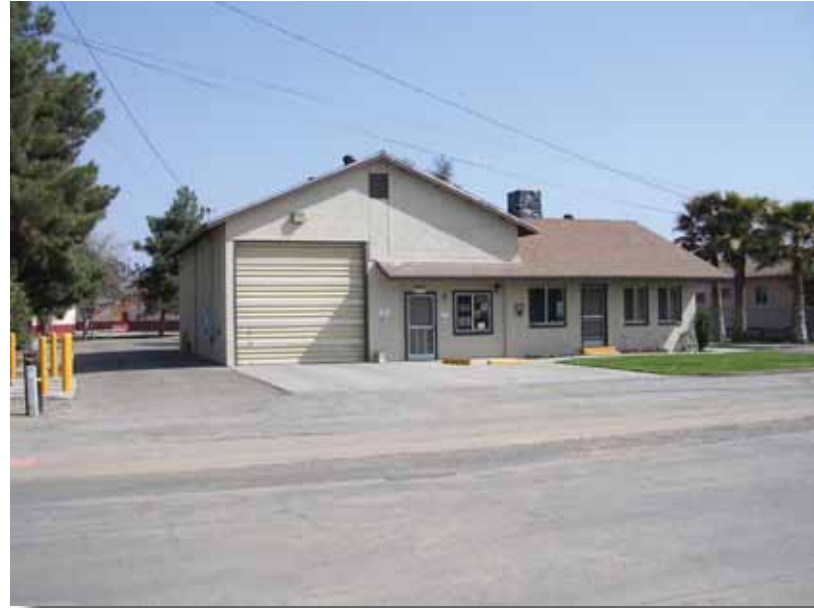
590 - Springville Fire Station
35659 Hwy 190, Springville, Ca.

General – This facility is approximately 46 years old with a total size of 3482 gross square feet. The Building(s) is/are 1 story/stories tall and constructed of a/an CMU structure with a/an Slab on Grade floor diaphragm on a/an Conventional footings foundation. The exterior consists of Exposed Concrete or CMU and Plywood in good condition while the interior is tackboard/paint in fair condition. The roof on this facility consists of built-up roofing, in fair condition, on a wood framing structural roof system. The overall structural system is in fair condition. The gypsum wallboard or plaster ceiling is rated to be in fair condition and the vinyl composition tiles (VCT) and vinyl asbestos tiles (VAT) floor is rated in fair condition.

Fire & Life Safety – The fire alarm system on this building is a/an None with a/an None sprinkler system. The security system consists of None and is in (not rated or N/A) condition.

HVAC – The HVAC system in this building consists of a/an Package Units that was installed 2000 and is rated to be in good condition. The reported history of breakdowns on this system is:
Has only happened once or twice

Electrical – The main electrical service (in amps) is 200 amps with the last upgrade being 2005. The electrical power system is rated to be in fair condition and the electrical lighting is rated to be in fair condition. Telephone and data communication systems appear to be in fair condition.

Abatement – There is asbestos in this building. Asbestos is located in: vat.
There may or may not be lead based paint in this building.

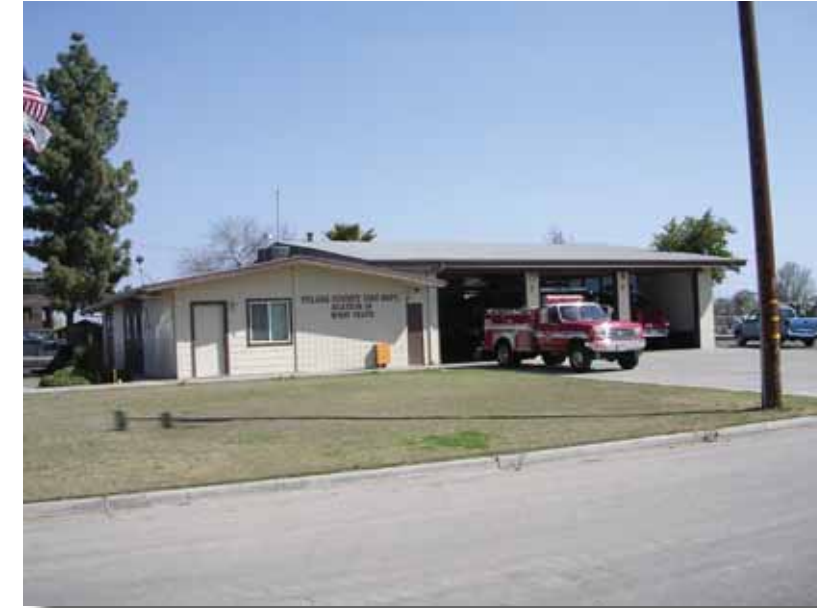
592 - Richgrove Fire Station
20890 Grove Drive, Richgrove, Ca.

- General –** This facility is approximately 46 years old with a total size of 2100 gross square feet. The Building(s) is/are 1 story/stories tall and constructed of a/an Wood Framed and CMU structure with a/an Slab on Grade floor diaphragm on a/an Conventional footings foundation. The exterior consists of Lath & Plaster and Exposed Concrete or CMU in good condition while the interior is plaster / paint in fair condition. The roof on this facility consists of composition shingle roofing, in fair condition, on a wood framing structural roof system. The overall structural system is in good condition. The gypsum wallboard or plaster ceiling is rated to be in good condition and the carpet and sheet vinyl floor is rated in fair condition.

- Fire & Life Safety –** The fire alarm system on this building is a/an None with a/an None sprinkler system. The security system consists of None and is in (not rated or N/A) condition.

- HVAC –** The HVAC system in this building consists of a/an Package Units that was installed 1999 and is rated to be in good condition. The reported history of breakdowns on this system is: Never

- Electrical –** The main electrical service (in amps) is 200 amps with the last upgrade being 1999. The electrical power system is rated to be in good condition and the electrical lighting is rated to be in fair condition. Telephone and data communication systems appear to be in fair condition.

- Abatement –** There may or may not be asbestos in this building. . There may or may not be lead based paint in this building.

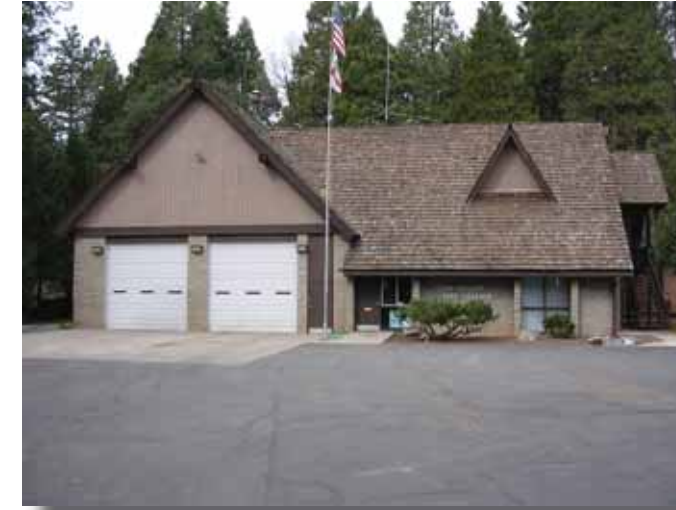
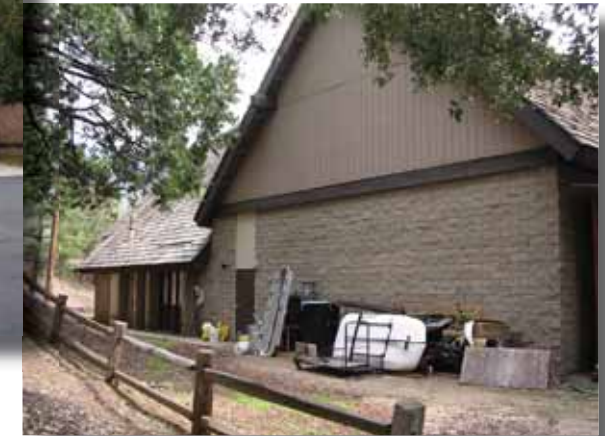
595 - Pine Mountain Fire Station
45122 Manter Meadow Drive, Pine Mountain, Ca.

General – This facility is approximately 24 years old with a total size of 2800 gross square feet. The Building(s) is/are 2 story/stories tall and constructed of a/an Wood Framed and CMU structure with a/an Slab on Grade floor diaphragm on a/an Conventional footings foundation. The exterior consists of Exposed Concrete or CMU and Plywood in good condition while the interior is sheetrock/paint in fair condition. The roof on this facility consists of composition shingle roofing, in poor condition, on a wood framing structural roof system. The overall structural system is in good condition. The gypsum wallboard or plaster ceiling is rated to be in fair condition and the carpet, vinyl composition tiles (VCT), and sheet vinyl floor is rated in poor condition.

Fire & Life Safety – The fire alarm system on this building is a/an None with a/an None sprinkler system. The security system consists of None and is in (not rated or N/A) condition.

HVAC – The HVAC system in this building consists of a/an Window AC Units, Wood Burning Stove, and Gas Furnace that was installed 1982 and is rated to be in fair condition. The reported history of breakdowns on this system is: Has only happened once or twice

Electrical – The main electrical service (in amps) is 200 amps with the last upgrade being unknown. The electrical power system is rated to be in good condition and the electrical lighting is rated to be in fair condition. Telephone and data communication systems appear to be in fair condition.

Abatement – There may or may not be asbestos in this building. .
There may or may not be lead based paint in this building.
